Counterfort Drain Performance in the Auckland Area

S. M. Torvelainen¹, GIPENZ, NZGS

¹Riley Consultants Ltd, P.O. Box 100253 North Shore, Auckland 0745; PH (09) 489 787; email storvelainen@riley.co.nz

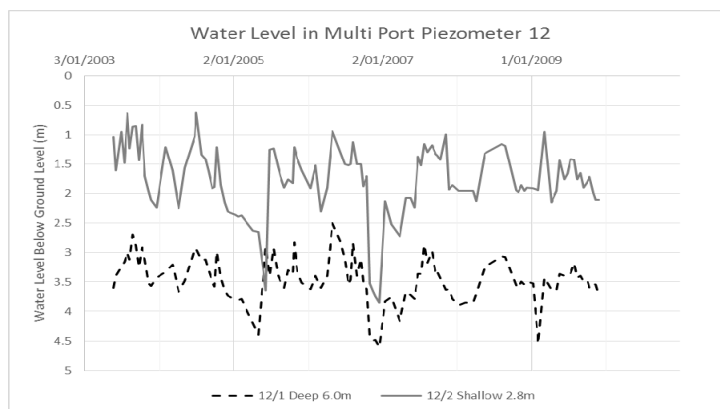
Four multiport piezometers were installed at the site; two in May 2003 (P12 and P13) and two in April 2004 (P14 and P15). Each piezometer had an upper screen from ground level to approximately 3.5 – 4.0m depth and a lower screen from below the depth of the shallow piezometer to the base of the drilled boreholes which were 6m deep. Figure 3 shows results from multiport piezometer 12 (over time period where both shallow and deep parts of the piezometers remained operational) clearly show that a downward groundwater gradient does exist at the site and hydrostatic pressure at the inferred failure surface level is less than indicated by a standpipe piezometer without a targeted response zone and may reflect a separate aquifer, a downward gradient in flow or a combination of both.

Figure 3. Multi Port Piezometer Performance

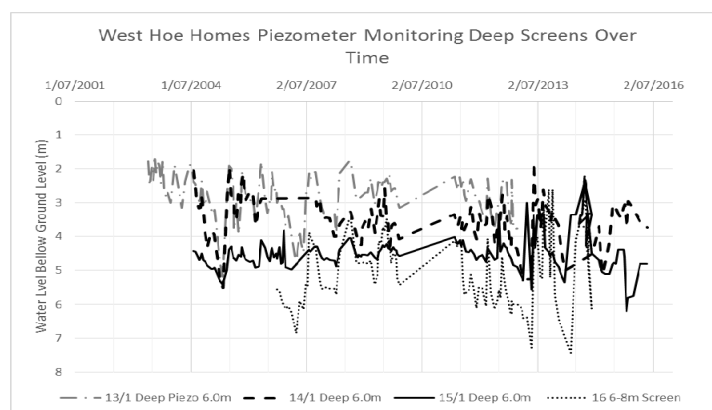
A selection of deep screen piezometers currently still in operation on site is shown in Figure 4 to assess the performance of counterfort drains on hydrostatic pressure at the depth of the inferred failure surface. No obvious trend is shown in these groundwater levels from when monitoring commenced that would indicate that the groundwater levels have risen over time. There does however appear to be some increased activity with P15/1 Deep and P16 over 2013 and winter spring 2014. However, peak groundwater levels for these piezometers coincided with their lowest recorded levels in the same period. For this period the rainfall does not follow any atypical trend. Observations on site, such as of concrete driveways and kerbings do not indicate any ground movement, however, an up to date survey of monitoring points has not recently been undertaken.

Figure 4. Ground water levels of deep screen piezometers over time
