SYMPOSIUM ON MONITORING OF DAMS

MONITORING OF DAMS

MONITORING OF CONCRETE GRAVITY DAMS

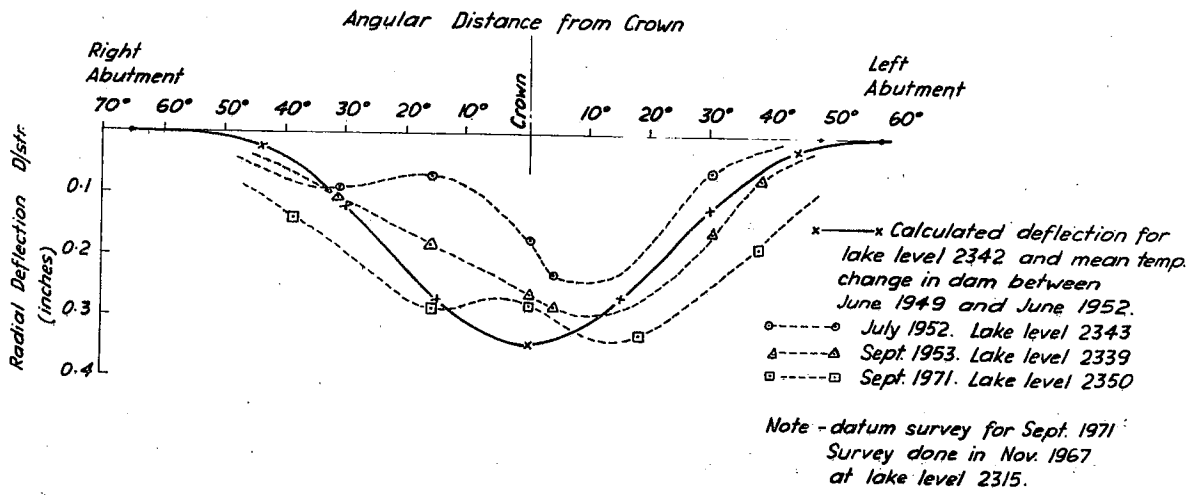
Fig. 2 - CLARK DAM - Radial Deflection of Crest Arch

The reservoir (Lake King William) was filled between 1949 and 1952. Deflection surveys carried out in July 1952 and September 1953, have been described by Thomas (2). The measured radial deflections obtained from those two surveys, the survey in September, 1971 and the calculated deflection curves are shown in fig 2. The asymmetry of the measured deflection curve was ascribed to differential temperature between the two abutments.

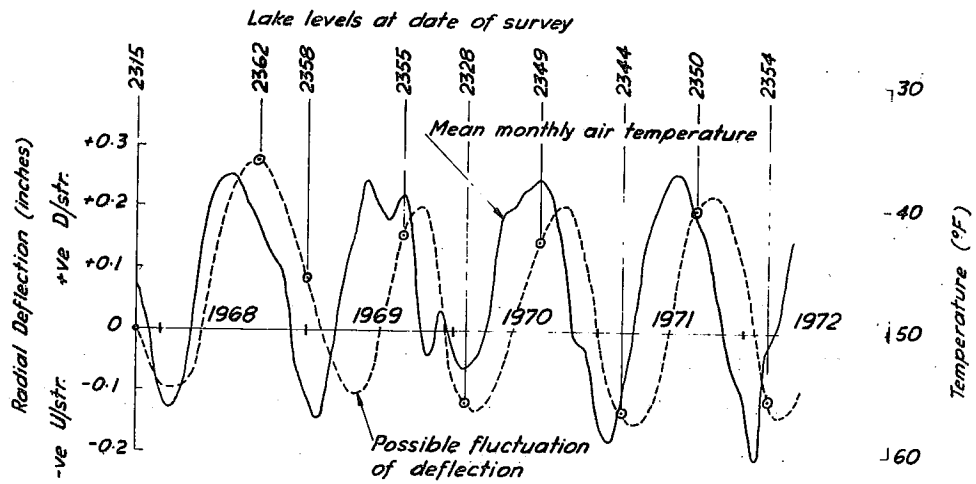
Fig. 3 - CLARK DAM - Radial Deflection at Centre of Crest.

The new datum survey was carried out in November, 1967 when the lake was at SL 2315. Since then two surveys have been done each year. Fig 3 shows the radial deflection at the centre of the crest for the various surveys, the corresponding water level and the plot of mean monthly air temperature. The correlation with temperature is obvious and masks any influence of varying water load.

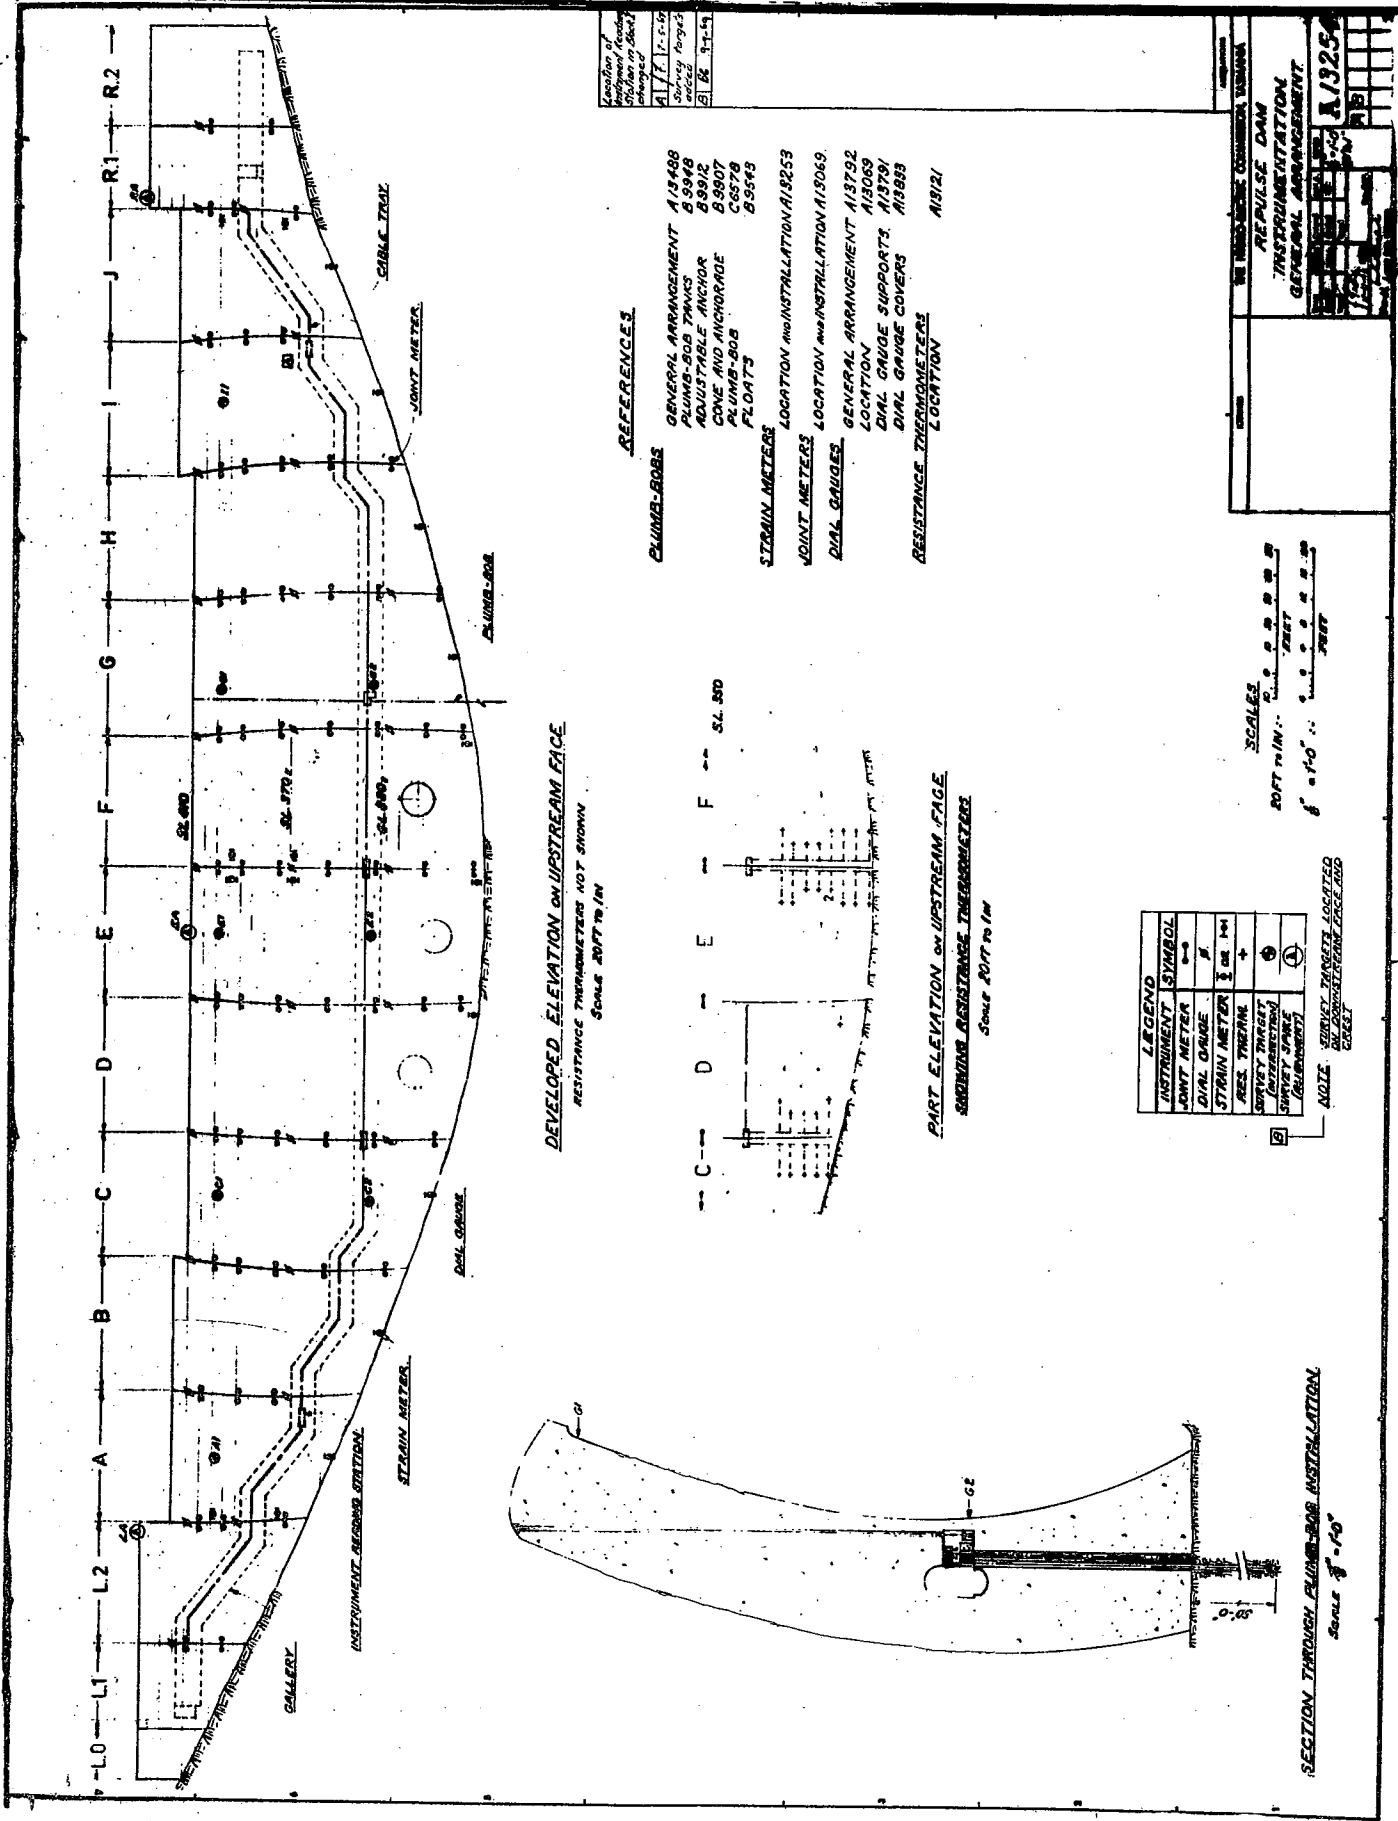
Fig. 4

**DEVELOPED ELEVATION ON UPSTREAM FACE**

RESISTANCE THERMOMETERS NOT SHOWN  
SCALE 20 FT TO 1 IN

The general arrangement of the instrumentation is shown in fig 4.

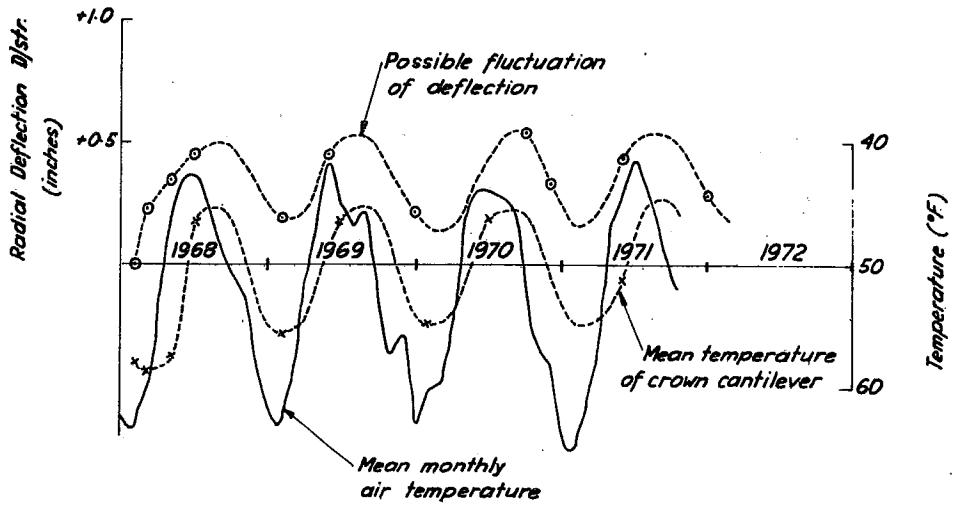
Fig. 5 - REPULSE DAM - Radial Deflection at Centre of Crest

The datum survey was carried out in February, 1968 just prior to filling the dam in early March, 1968. Radial deflection at the centre of the dam 10 ft. below crest level, is shown in fig 5 together with mean monthly air temperature and the mean temperature of the crown cantilever. It may be seen that very little change in mean temperature occurred during filling so that the corresponding deflection is due almost entirely to the water load.

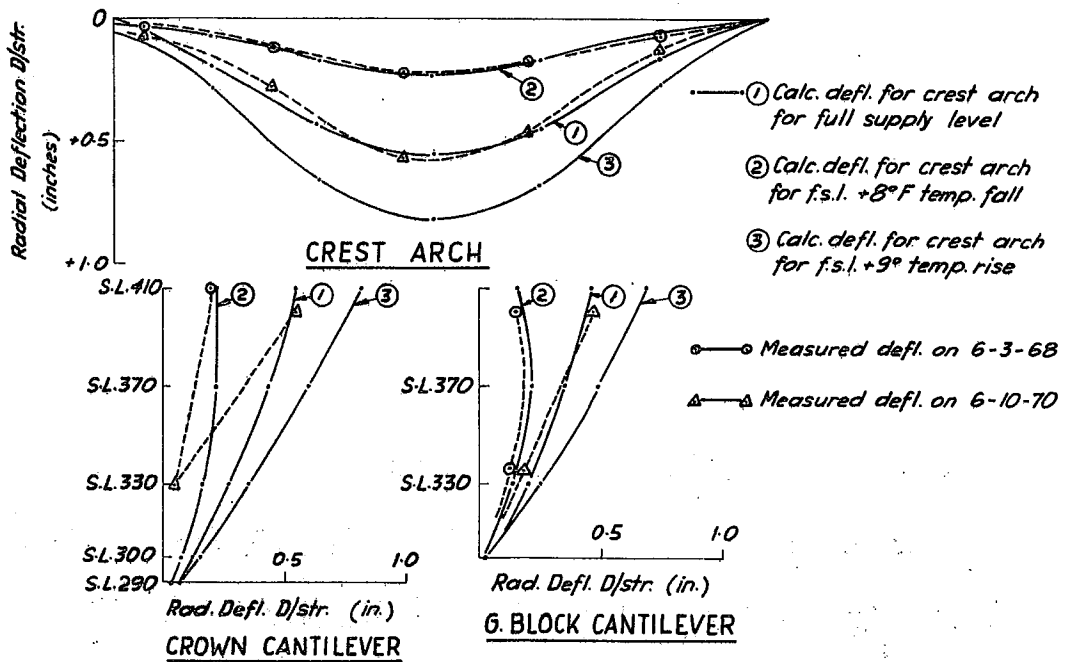
FIG. 6 - REPULSE DAM - Radial Deflection of Crest Arch and Two Cantilevers

In fig 6 the deflection due to the first filling is compared with the calculated deflection due to water load only for the crest arch, the crown cantilever and the G block cantilever. The calculated deflection was obtained by trial load analysis using a value of 5 for the ratio of elastic modulus of concrete to foundation and an elastic modulus for concrete of  $3 \times 10^6$  lb/in<sup>2</sup>. The measured deflection was only 40% of that calculated indicating a considerably greater foundation modulus than that adopted.

Also shown in fig 6 are the calculated deflection curves for water load plus a 9°F temperature rise and water load plus an 8°F temperature fall, the range in deflection for the 17°F change in temperature being 0.59 inches. The measured ranged in deflection for a 12°F change in mean temperature of the crown cantilever has been 0.37 inches.

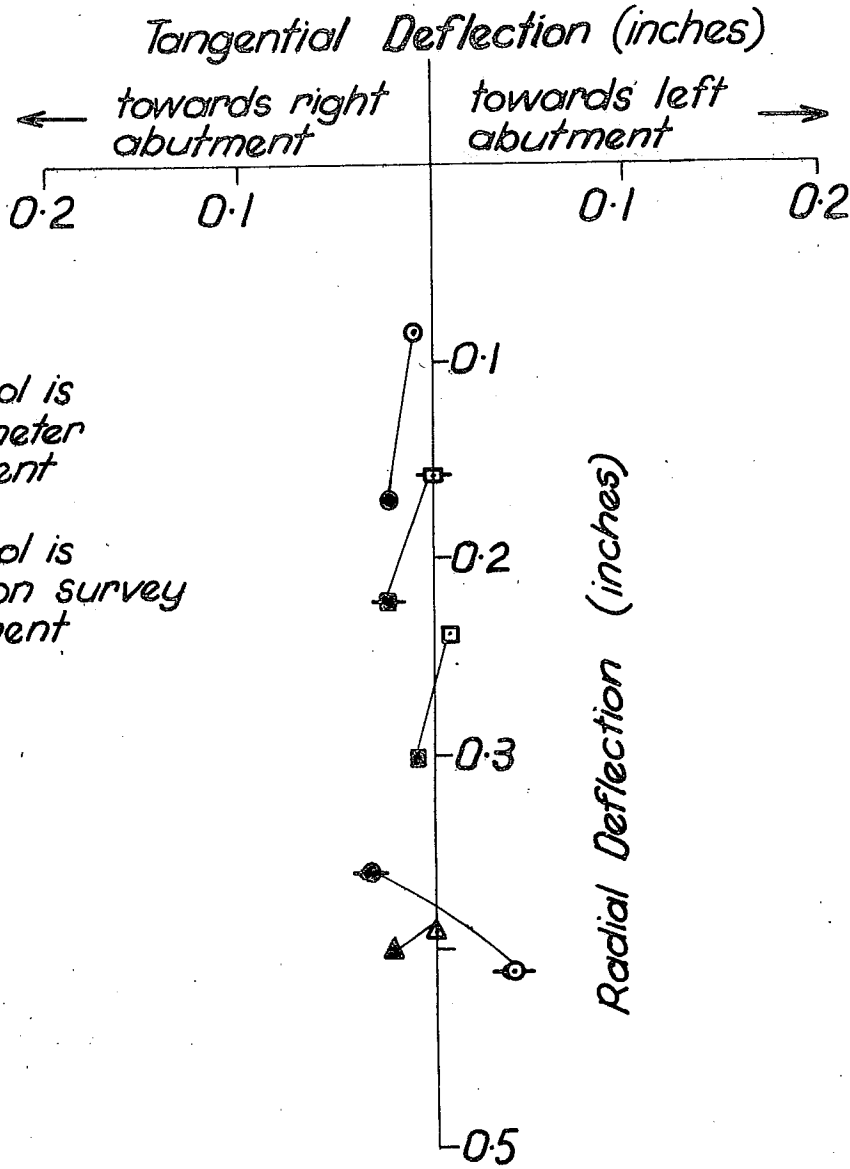
Open symbol is  
co-ordinometer  
measurement

Solid symbol is  
triangulation survey  
measurement

Fig 7 - REPULSE DAM  
Comparison of Co-ordinometer and  
Triangulation Survey Measurements  
for Target G1.

Comparison between the co-ordinometer measurements on the pendulums and the triangulation surveys shows a maximum difference of inches in the radial direction - fig 7.

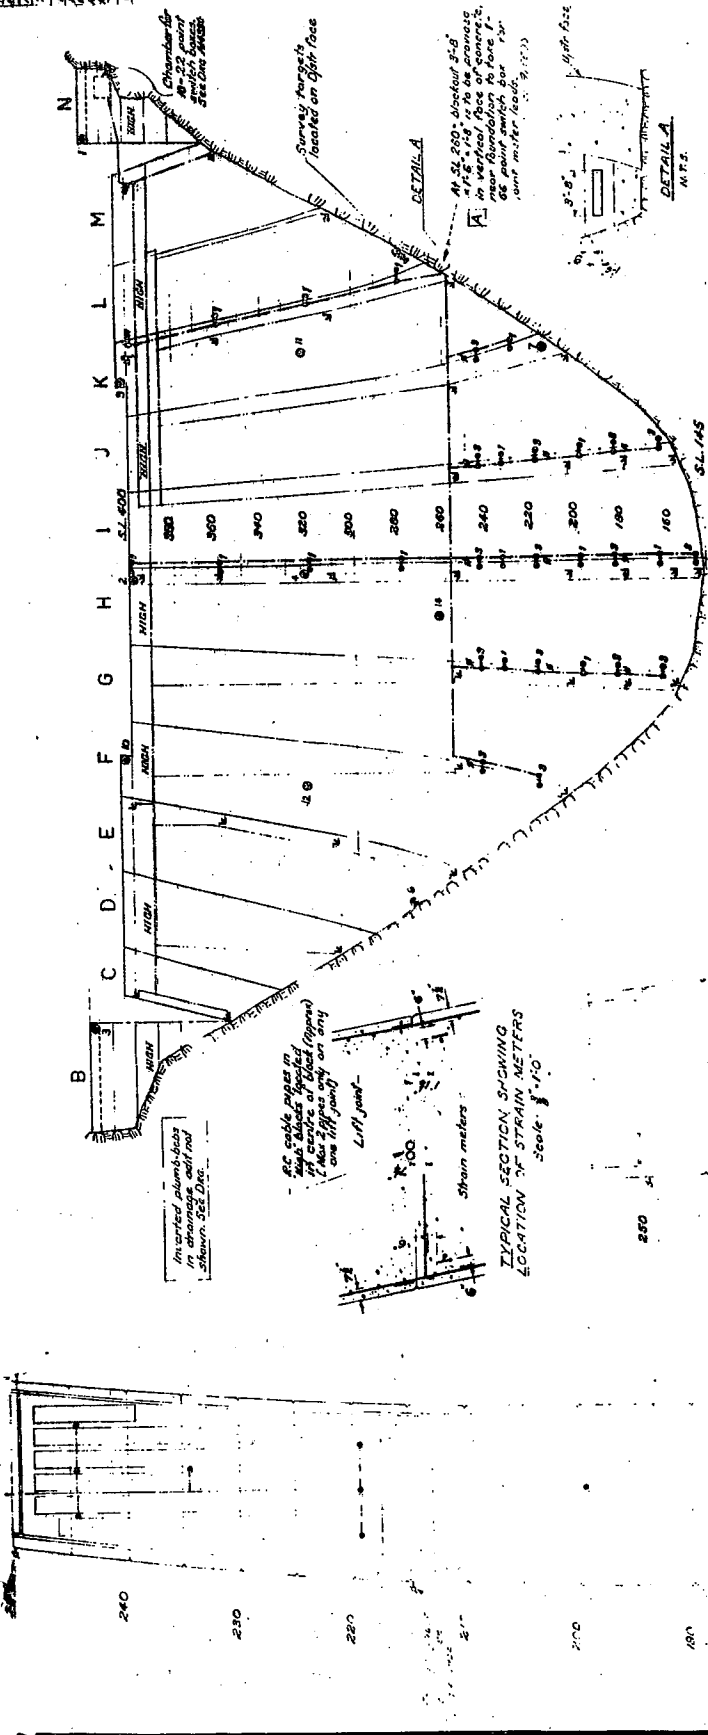
**DEVELOPED ELEVATION ON UPSTREAM FACE**  
Scale: 20 FT TO 1 IN

**POSITION OF JOINT METERS (Carbon Type Gages)**

Fig 8 shows the instrumentation system installed and consisting of:-

No pendulums were installed because of the pronounced vertical curvature. In addition to the above and not shown in fig 8 two adits in a low modulus zone in the left abutment were instrumented to measure foundation deformation. In the adit at SL 350 there are 3 rock compression gauges of 50 ft. length, one in the radial direction and two in the tangential direction, and tape gauges along the 115 ft. length of adit which is approximately in the radial direction. In the adit at SL 284 there are 5 rock compression gauges each 50 ft. long. Two of these are in the vertical direction, two are in the horizontal tangential direction and one in the horizontal radial direction.

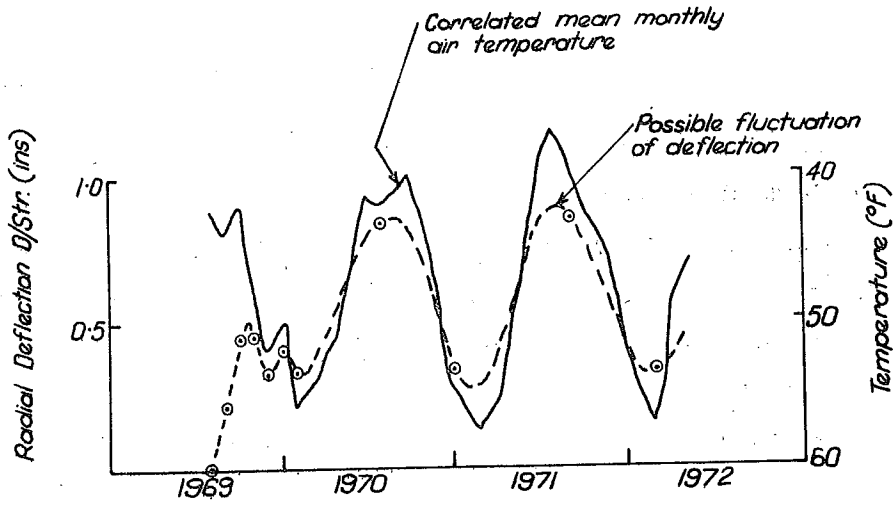
Fig 9 - DEVILS GATE DAM - Radial Deflection at Centre of Crest

The deflection at the centre of the crest is shown in fig 9 together with a correlated mean monthly air temperature. It will be noted that there is virtually no lag between the mean monthly temperature and the temperature movement of the dam and this is to be expected in such a thin structure.

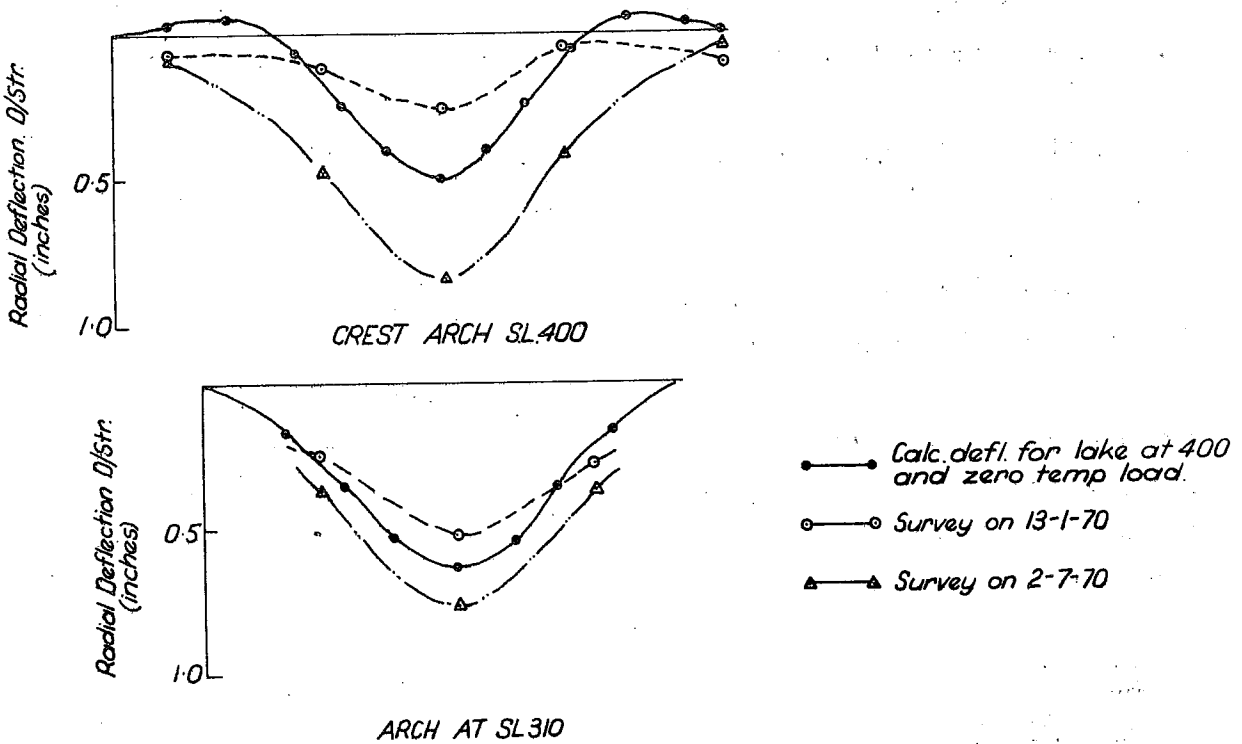
Fig 10 - DEVILS GATE DAM - Radial Deflection of Two Arches

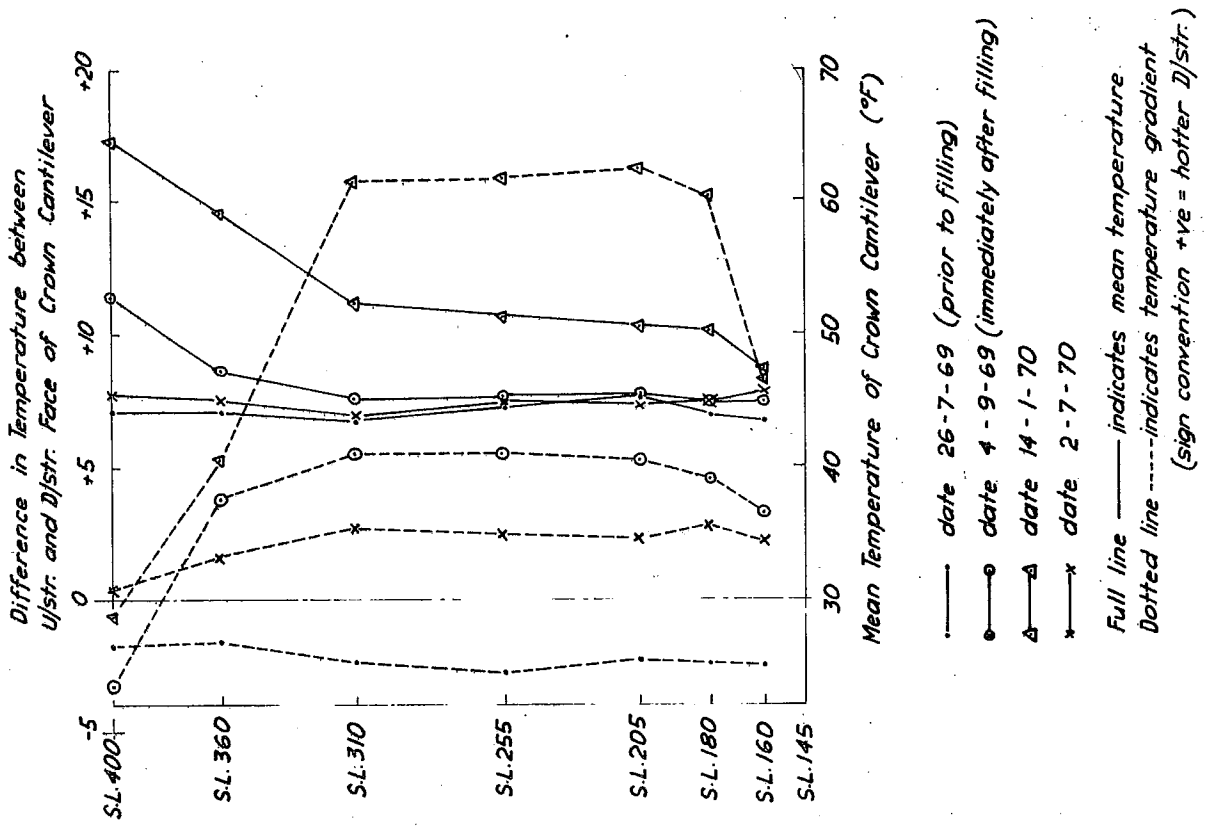
FIG. 12 - DEVILS GATE DAM  
Temperature of Crown Cantilever

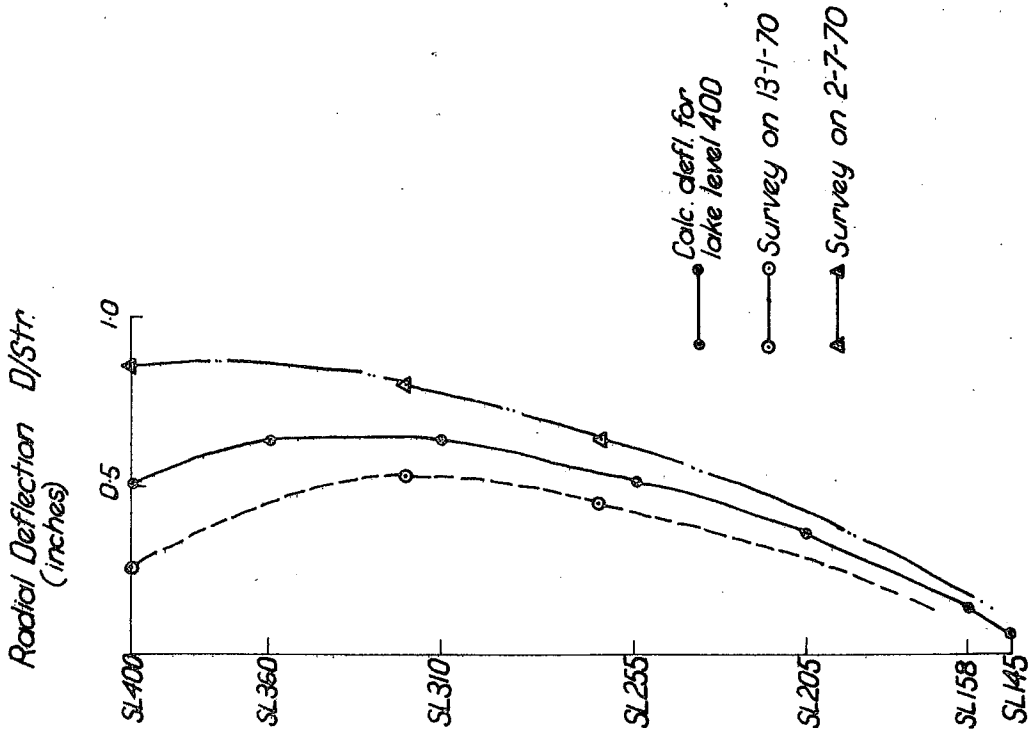
Fig 11- DEVILS GATE DAM  
Radial Deflection of  
Crown Cantilever

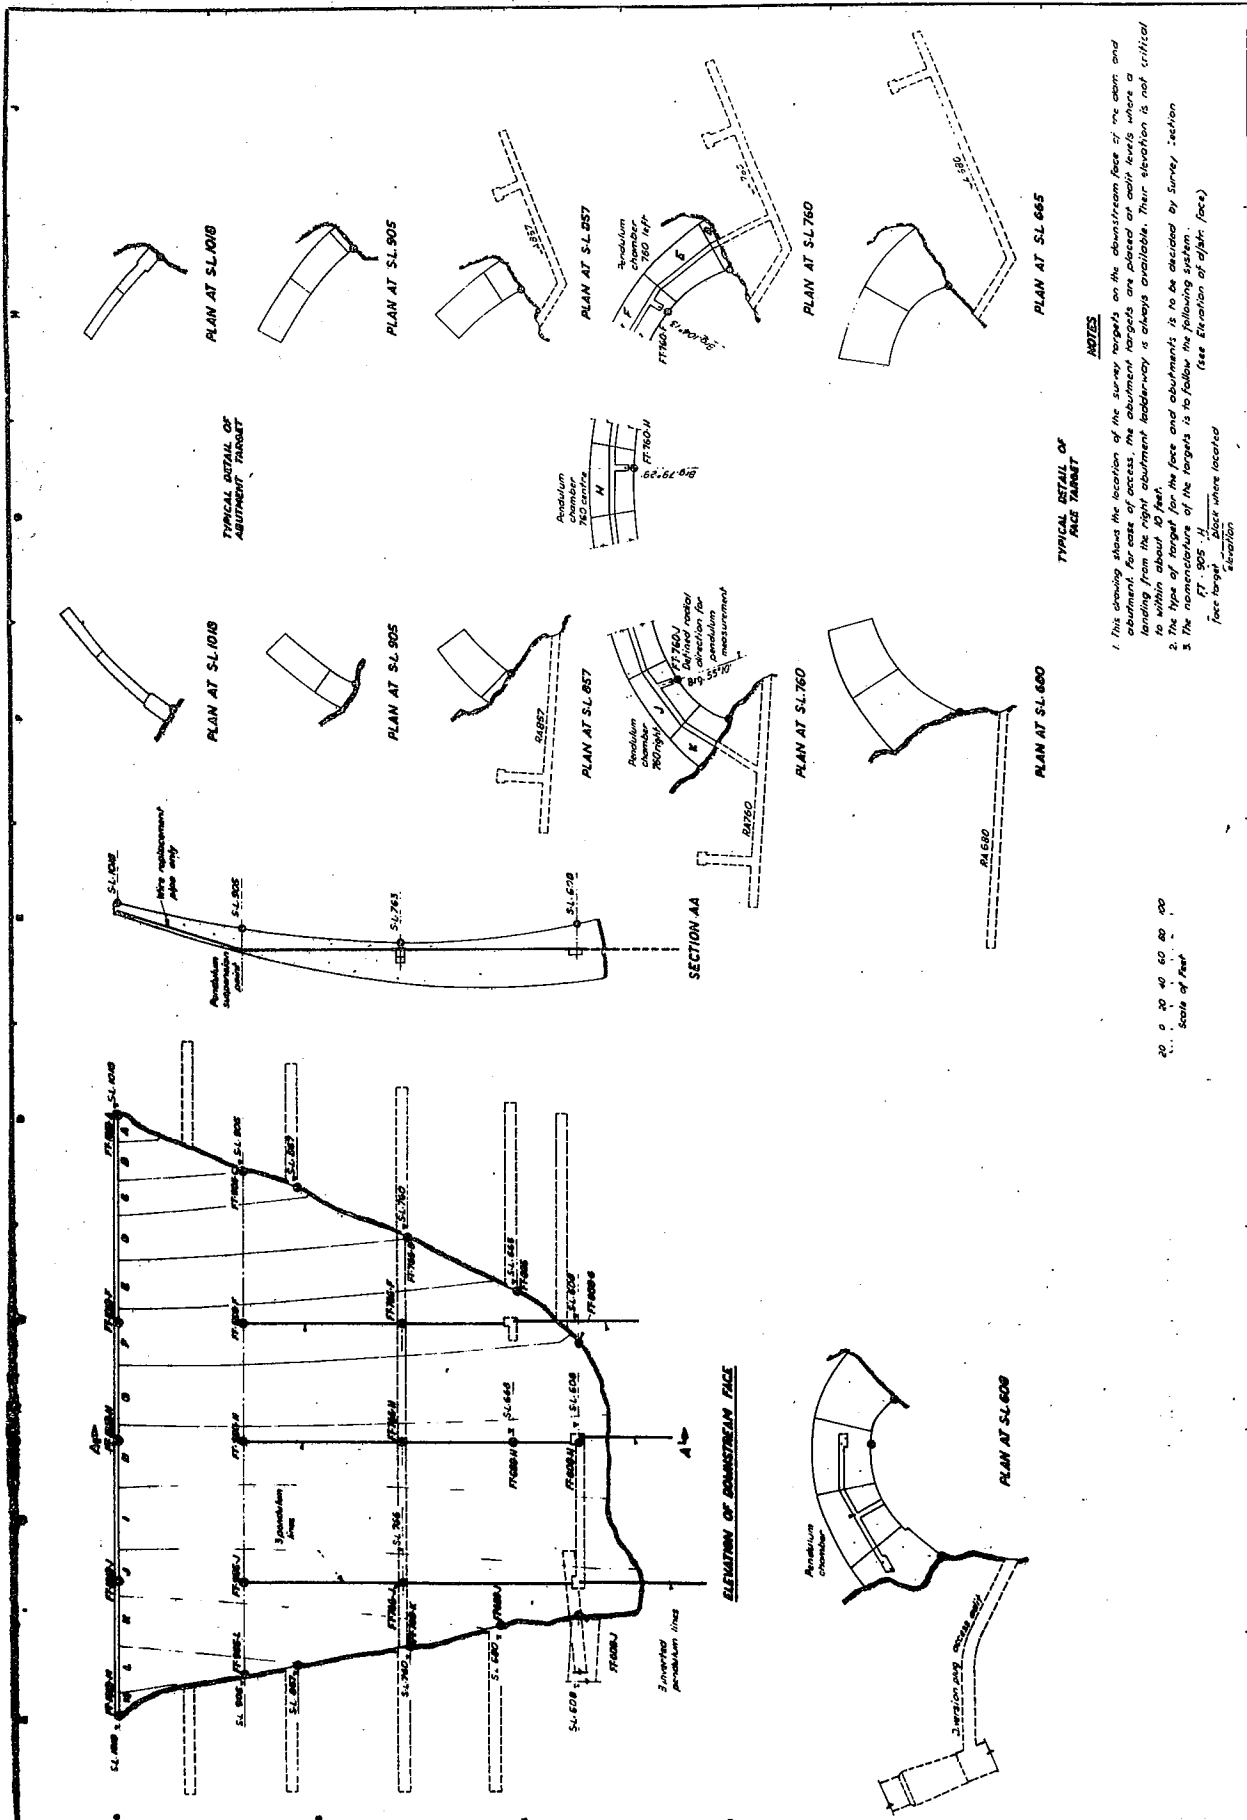
1. This drawing shows the location of the survey targets on the downstream face of the dam and abutment. For ease of access, the abutment targets are placed at odd levels where a landing from the right abutment ladder-way is always available. Their elevation is not critical to within about 10 feet.
2. The type of target for the face and abutments is to be decided by Survey Section.
3. The nomenclature of the targets is to follow the following system:  
 (a) 'SL' - Station where located  
 (b) 'Face' - Face where located  
 (c) 'Target' - Target where located

- 23 survey targets (fig 15)
- 3 suspended and 3 inverted pendulums (fig 15). The suspended pendulums will hang from a suspension point at SL 905, pass through intermediate measuring chambers at SL 760 and terminate near the base of the dam. The inverted pendulums will be anchored 50 to 80 ft. below the foundation surface in cased 7 in. dia. drill holes and extend to the same chambers in which the suspended pendulums are terminated.
- 18 clinometer positions fig 13 of 1 in. base length, generally in orthogonal pairs to measure rotation in the radial and tangential directions.
- 150 joint meters, fig 13 and 16
- 30 resistance thermometers fig 17
- 32 piezometers fig 14
- 18 rock compression meters fig 14 and 18
- 1 MO2 accelerograph fig 13
- 4 Wilmot seismoscopes fig 13

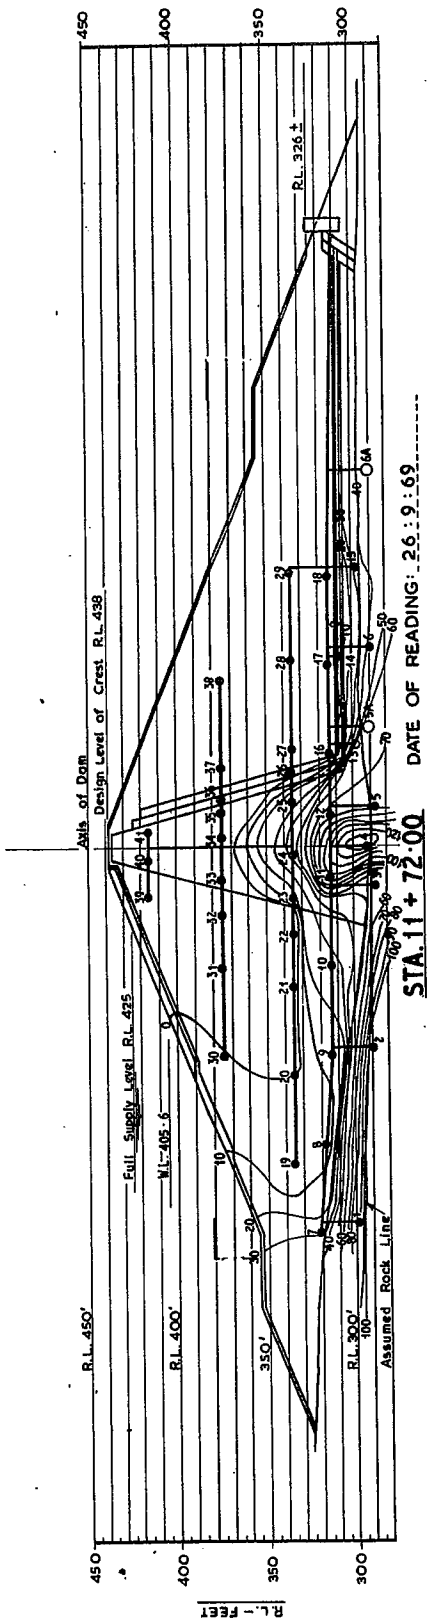
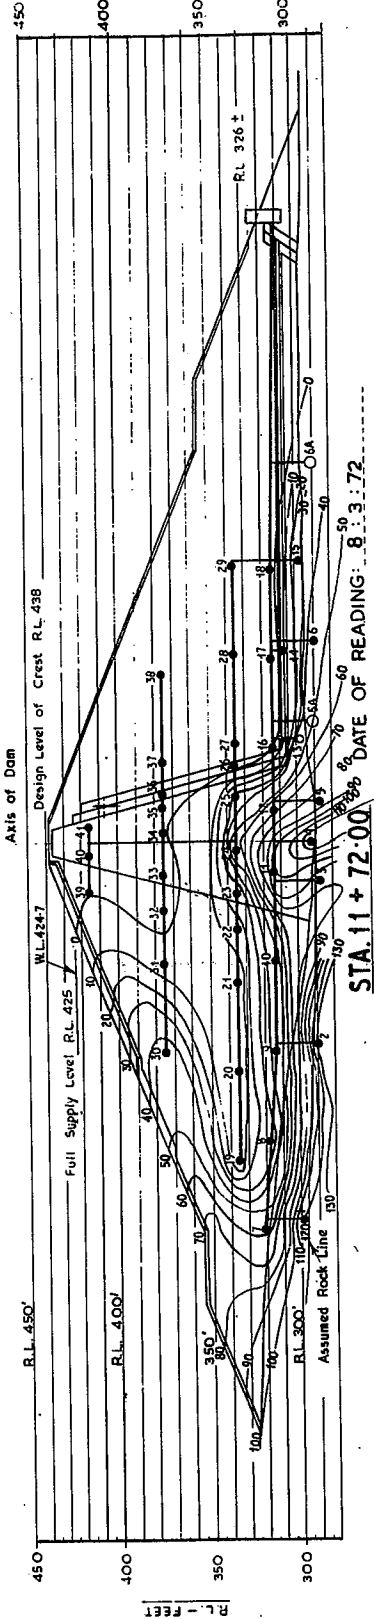
Figure 2

STA. 11 + 72.00 DATE OF READING: 2.6.9.69

STA. 11 + 72.00 DATE OF READING: 8.3.72

LIDDELL POWER STATION  
COOLING WATER DAM  
PORE PRESSURE DIAGRAMS

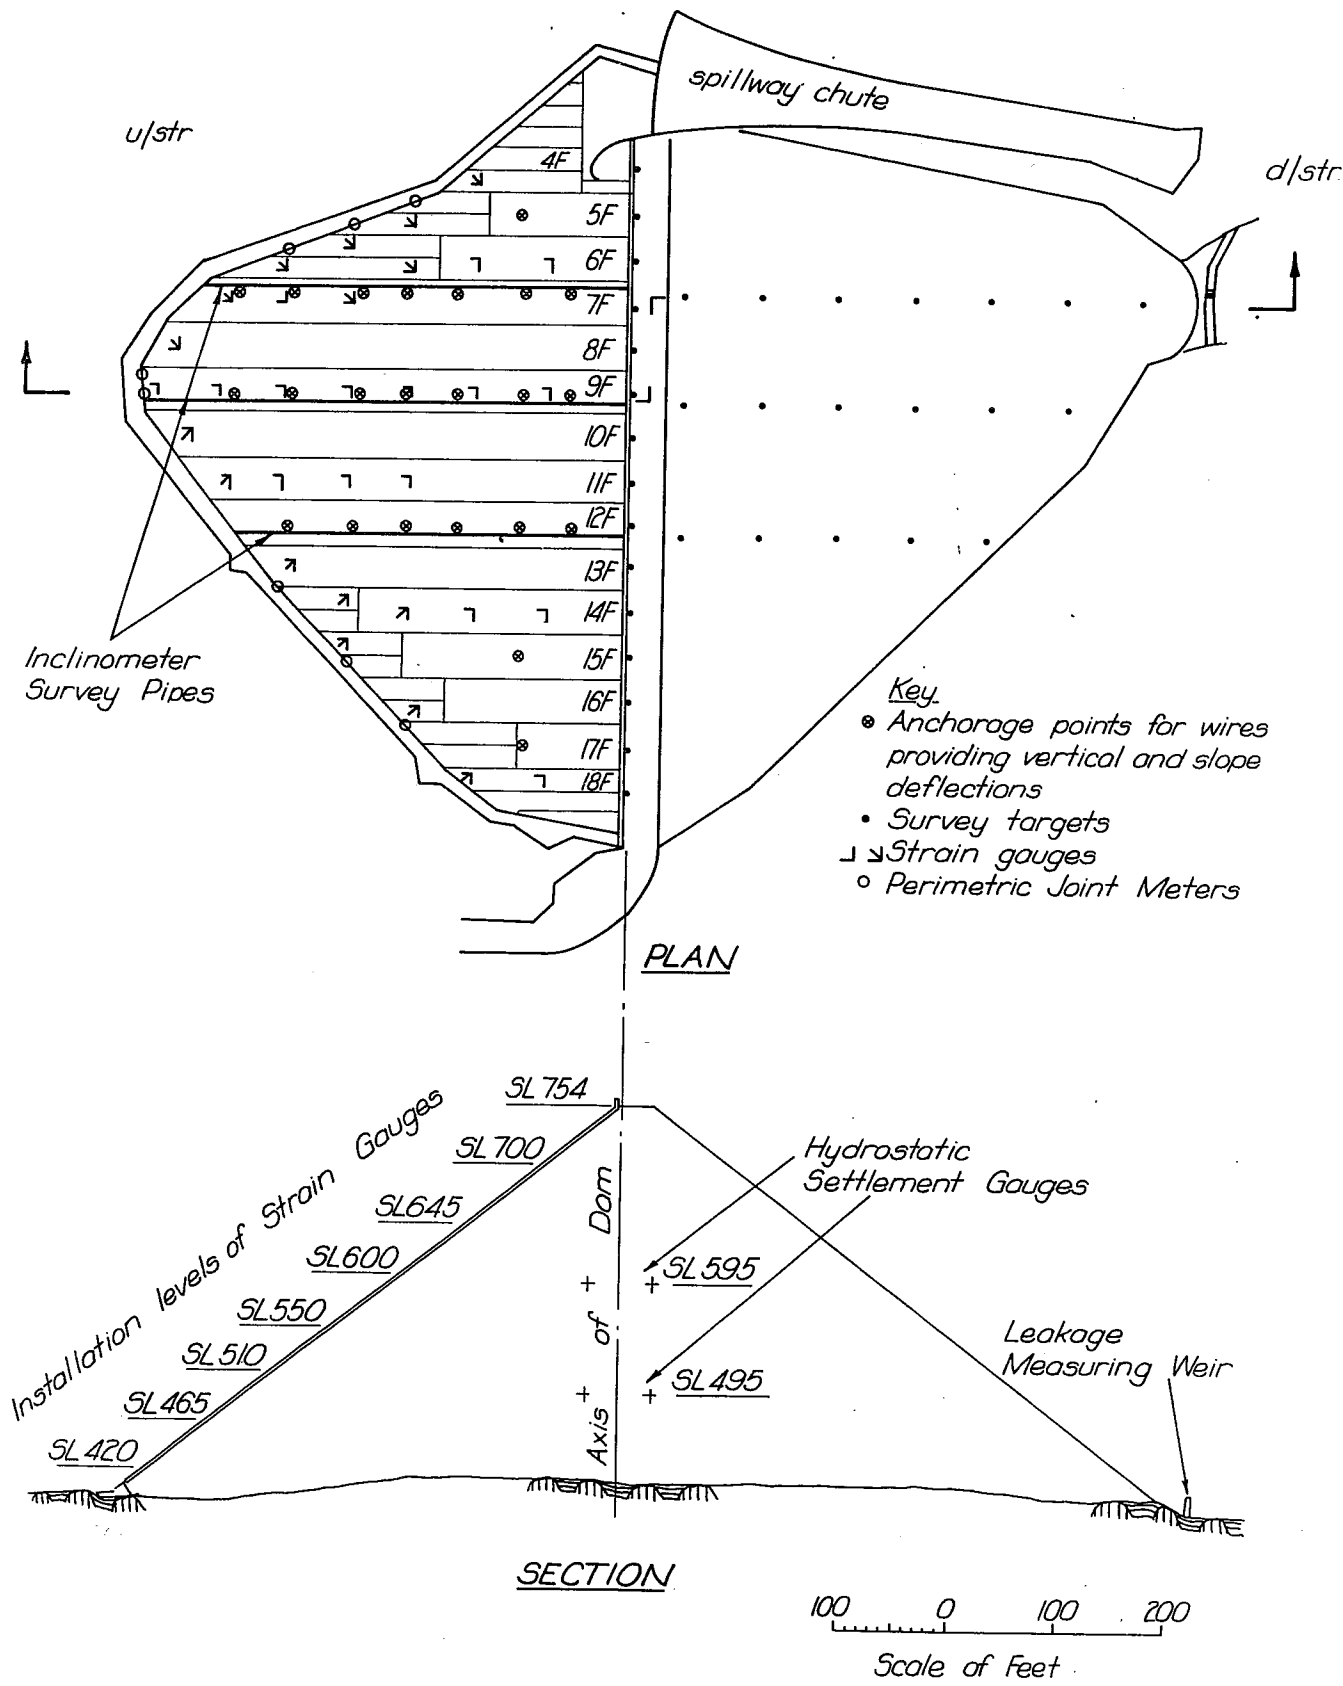
Fig. 1. CETHANA DAM - GENERAL ARRANGEMENT OF INSTRUMENTATION

Not all of these measurements have been carried out on each of the dams. The most comprehensive instrumentation system was provided at Cethana Dam as it is a high dam and one of the first of its type and size to be constructed of rolled rockfill. The general arrangement of Cethana instrumentation is shown in fig 1. Instrumentation of the other dams is shown in fig 2 - Wilmot; fig 3 - Paloona; fig 4 - Serpentine; and fig 5 - Scotts Peak. There are no embedded instruments in Mackenzie Dam on which monitoring is minimal and limited to settlement observations on a few crest targets and leakage measurement.

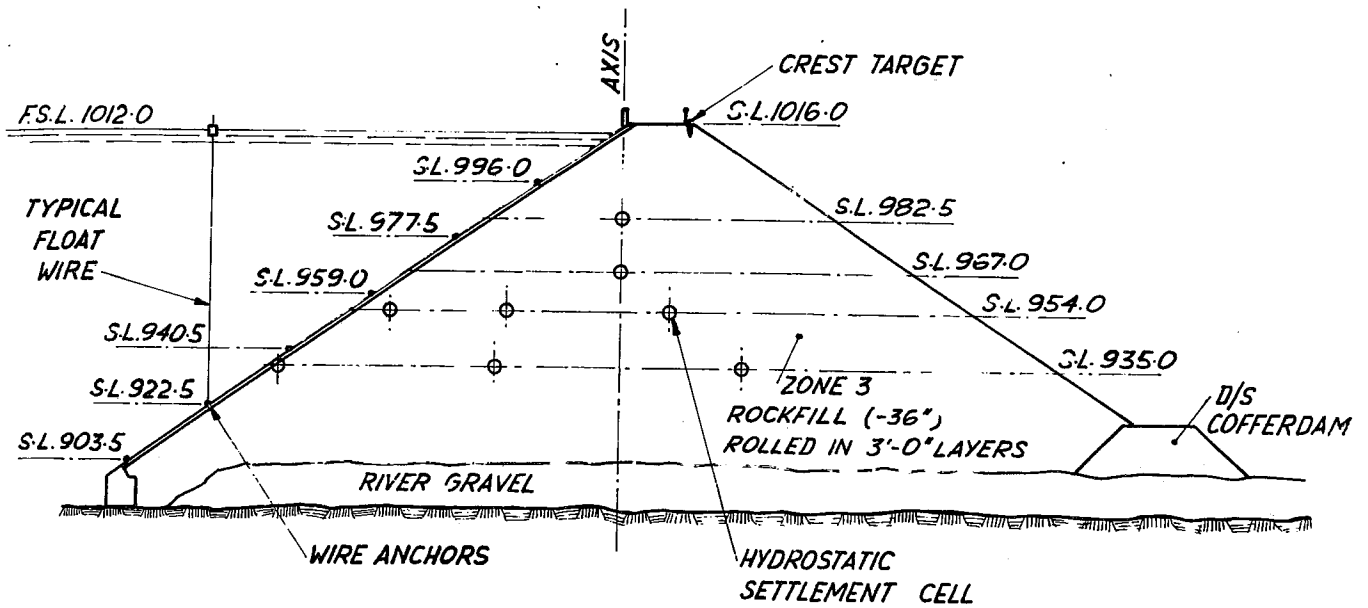
**FIG. 4 SERPENTINE DAM - INSTRUMENTATION**

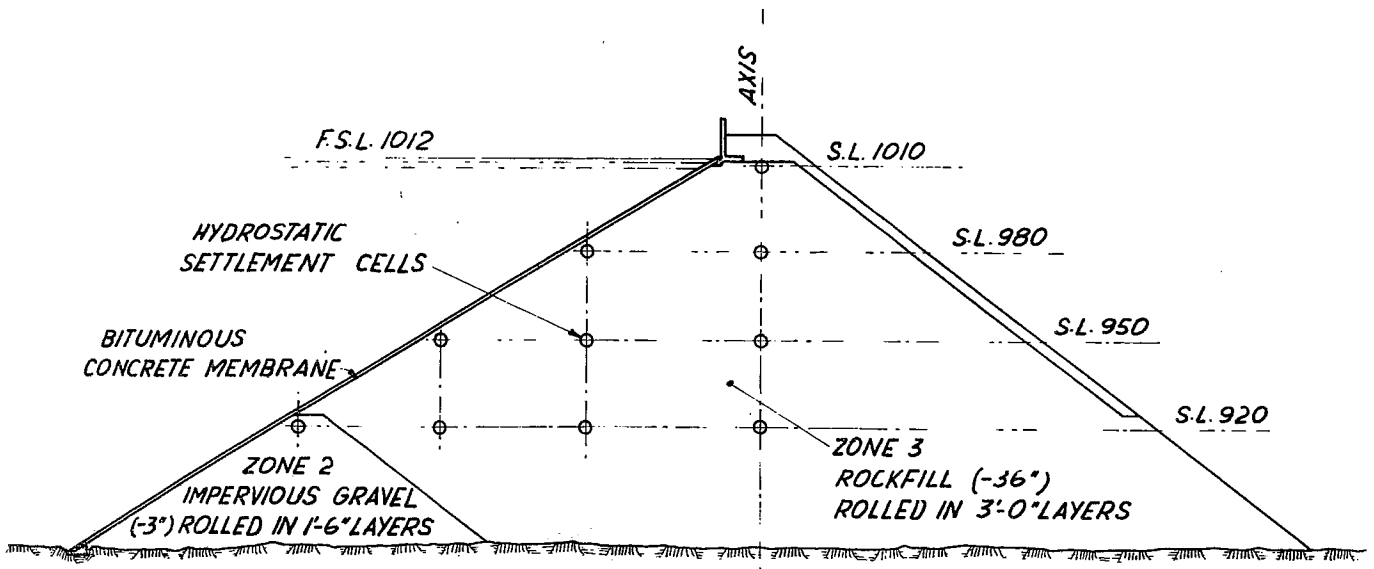
**FIG. 5 SCOTTS PEAK DAM - INSTRUMENTATION**

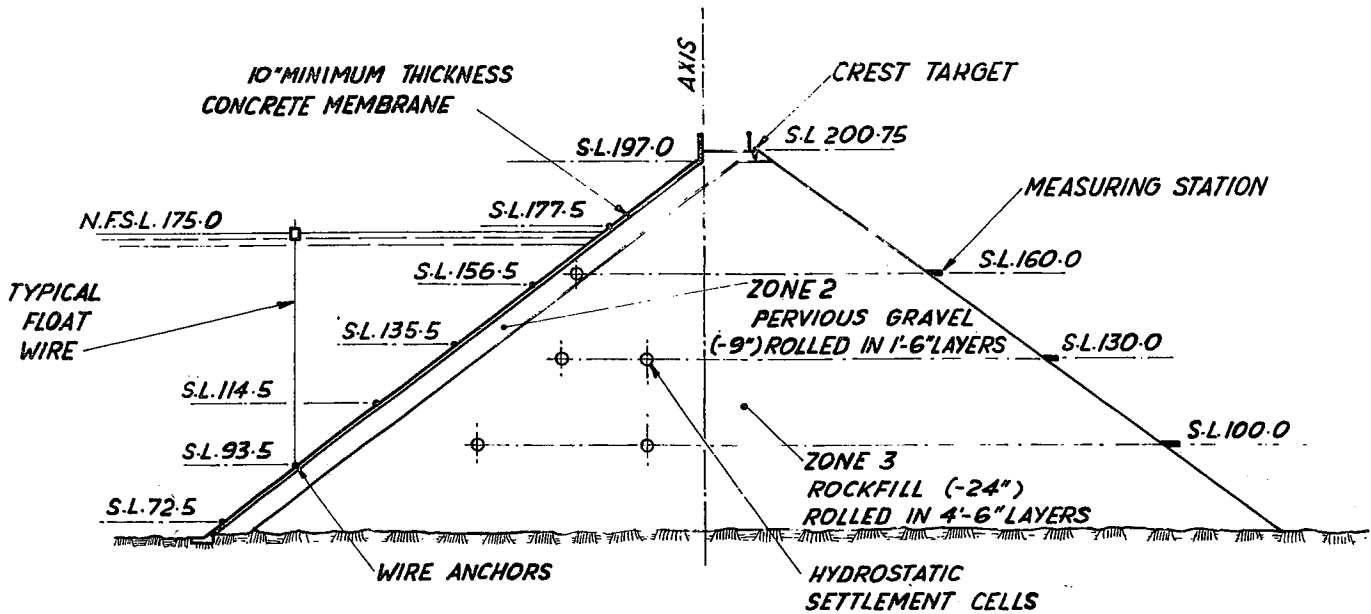
FIG. 3 PALOONA DAM - INSTRUMENTATION

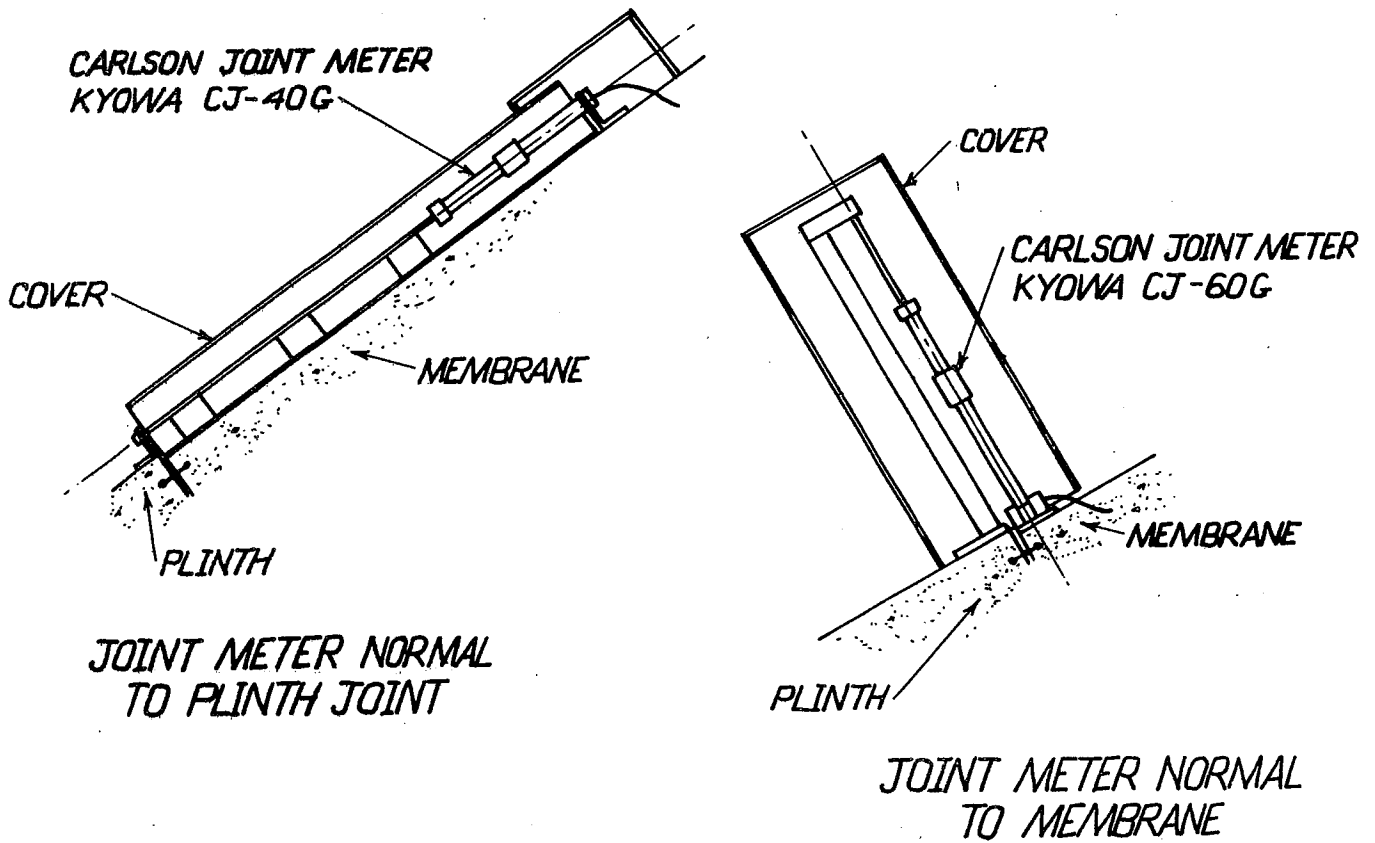
**FIG 6 - JOINT METER INSTALLATION**

The instrument used to measure deflection of the membrane relative to the plinth is a 360 mm long Carlson type joint meter (Kyowa CJ-40G). The meter is attached to an anchor on the membrane and is connected to an anchor on the plinth by a 2 ft long by  $\frac{1}{4}$  in. dia. stainless steel rod. This arrangement, shown in fig 6, was designed to avoid shear on the meter due to movement normal to its axis.

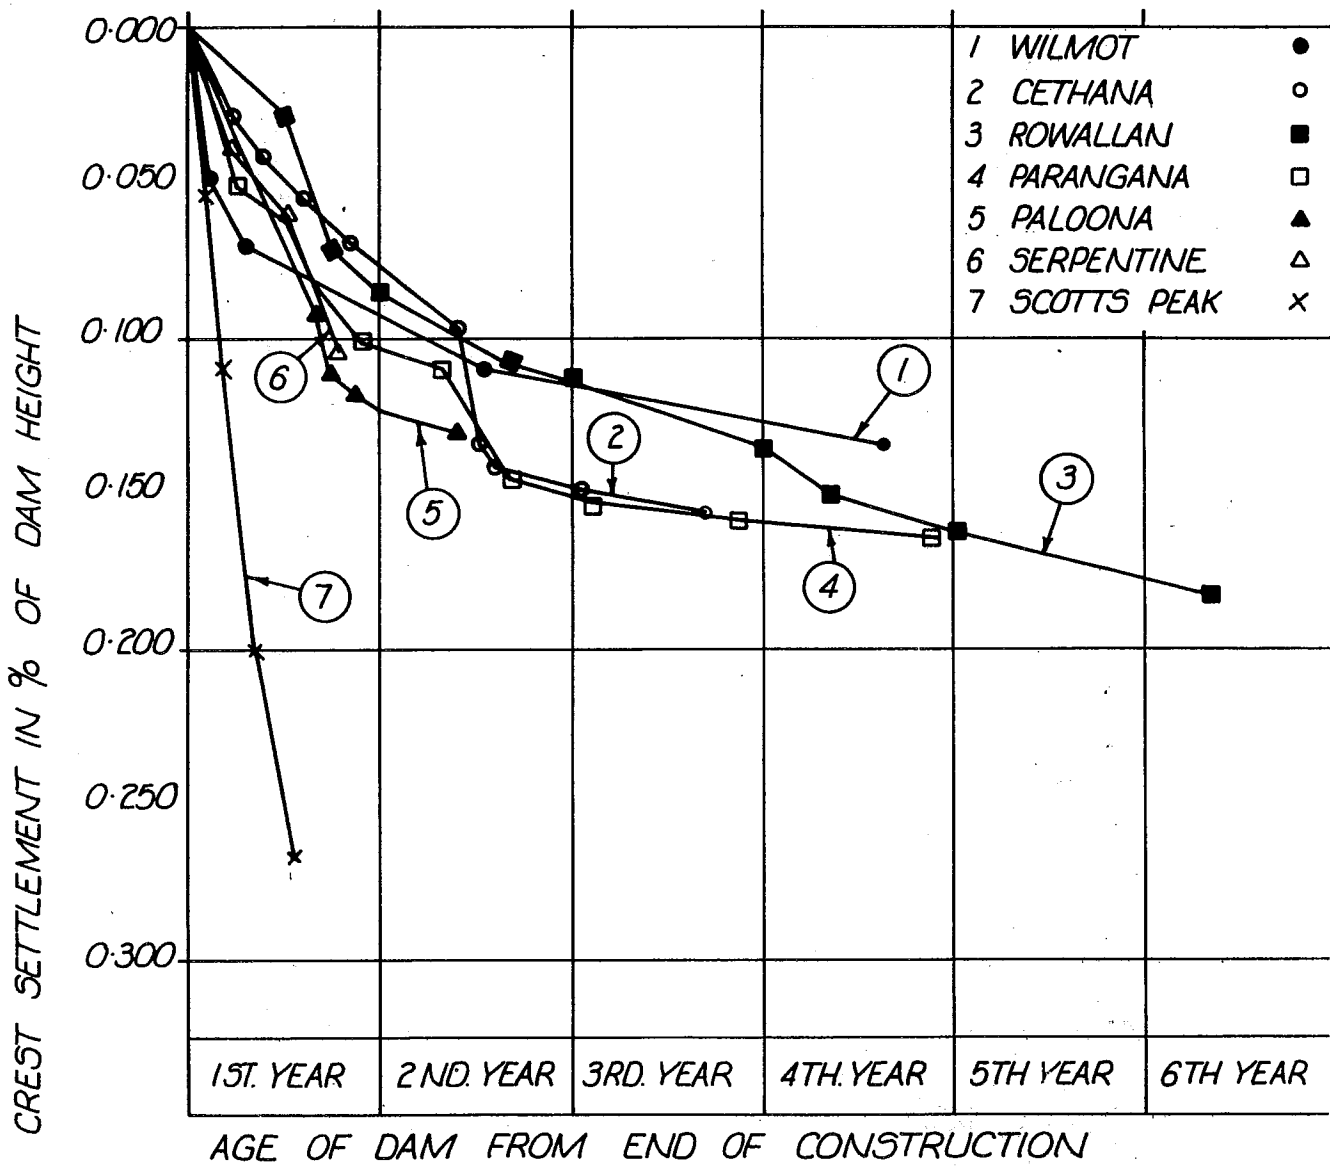
FIG.7- LONG TERM SETTLEMENT

Crest settlement since the end of construction of 7 dams is shown in fig 7. Settlement is expressed as a percentage of the height of the dam. Two central core dams, Rowallan and Parangana, have been included because they are representative of rolled fill construction.
