SYMPOSIUM ON MONITORING OF DAMS

MONITORING OF DAMS

MONITORING OF CONCRETE GRAVITY DAMS

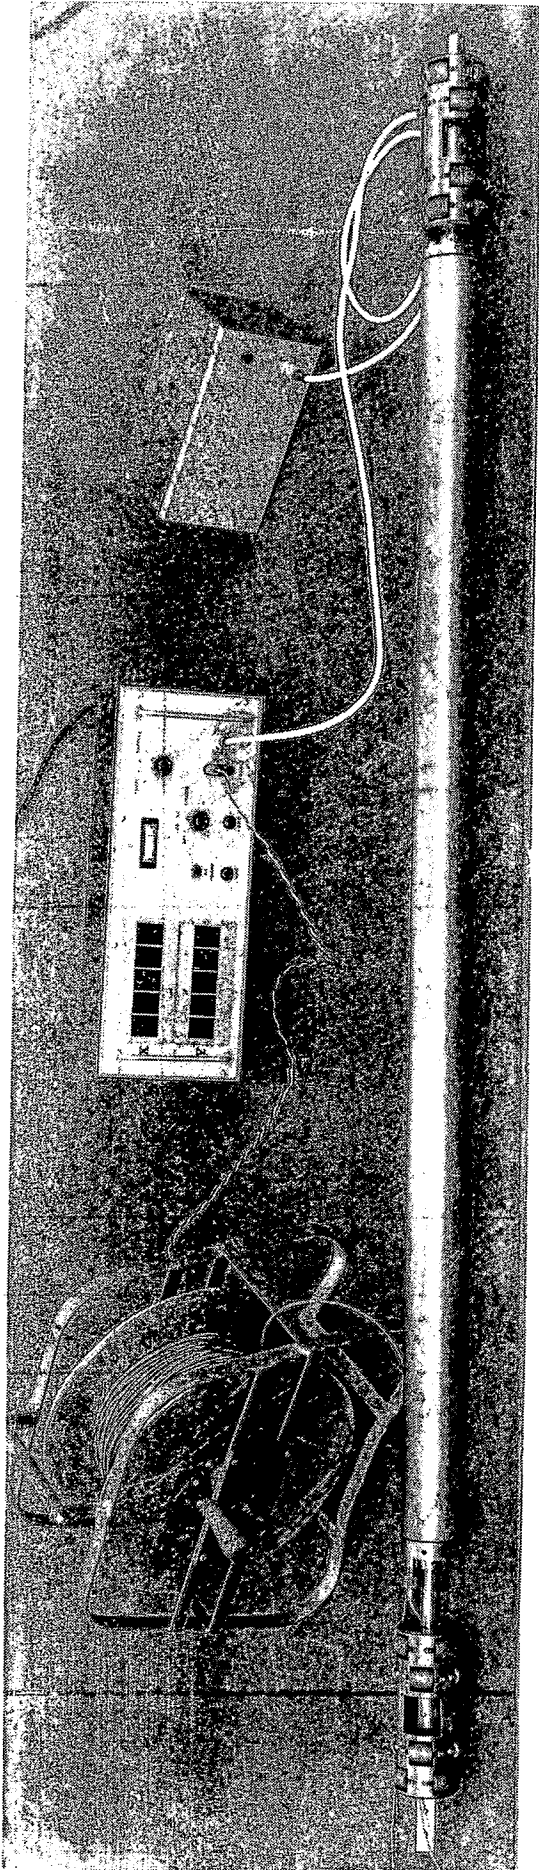
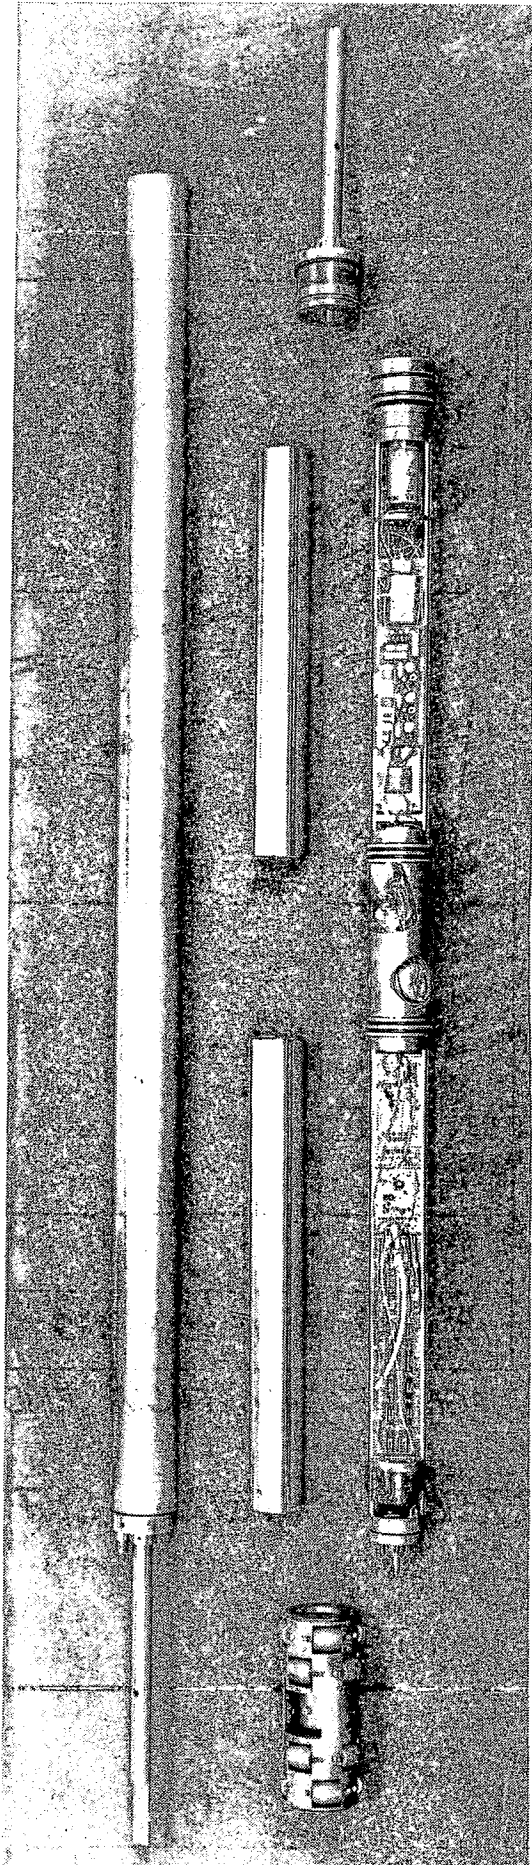
above: - probe, cable drum, digital display unit and power supply  
below: - probe disassembled

FIG 8 - WATT INCLINOMETER

The instrument was designed and constructed by Mr. P.A. Watt of the University of Tasmania and is called the Watt Inclinometer. It comprises a multi-wheeled  $2\frac{1}{2}$  in diameter by 5 ft long probe, a power supply and digital display unit - fig 8. The probe contains two force balanced servo - accelerometers and associated electronic equipment. The mounting containing the accelerometers is automatically rotated so that the axis of one of the accelerometers is maintained normal to a vertical plane through the probe. This accelerometer measures the inclination of the probe axis and its output is digitised and telemetered to the display unit at the crest of the dam. The probe is lowered down the pipe by 5 ft long steel rods and readings are taken at rod length intervals.

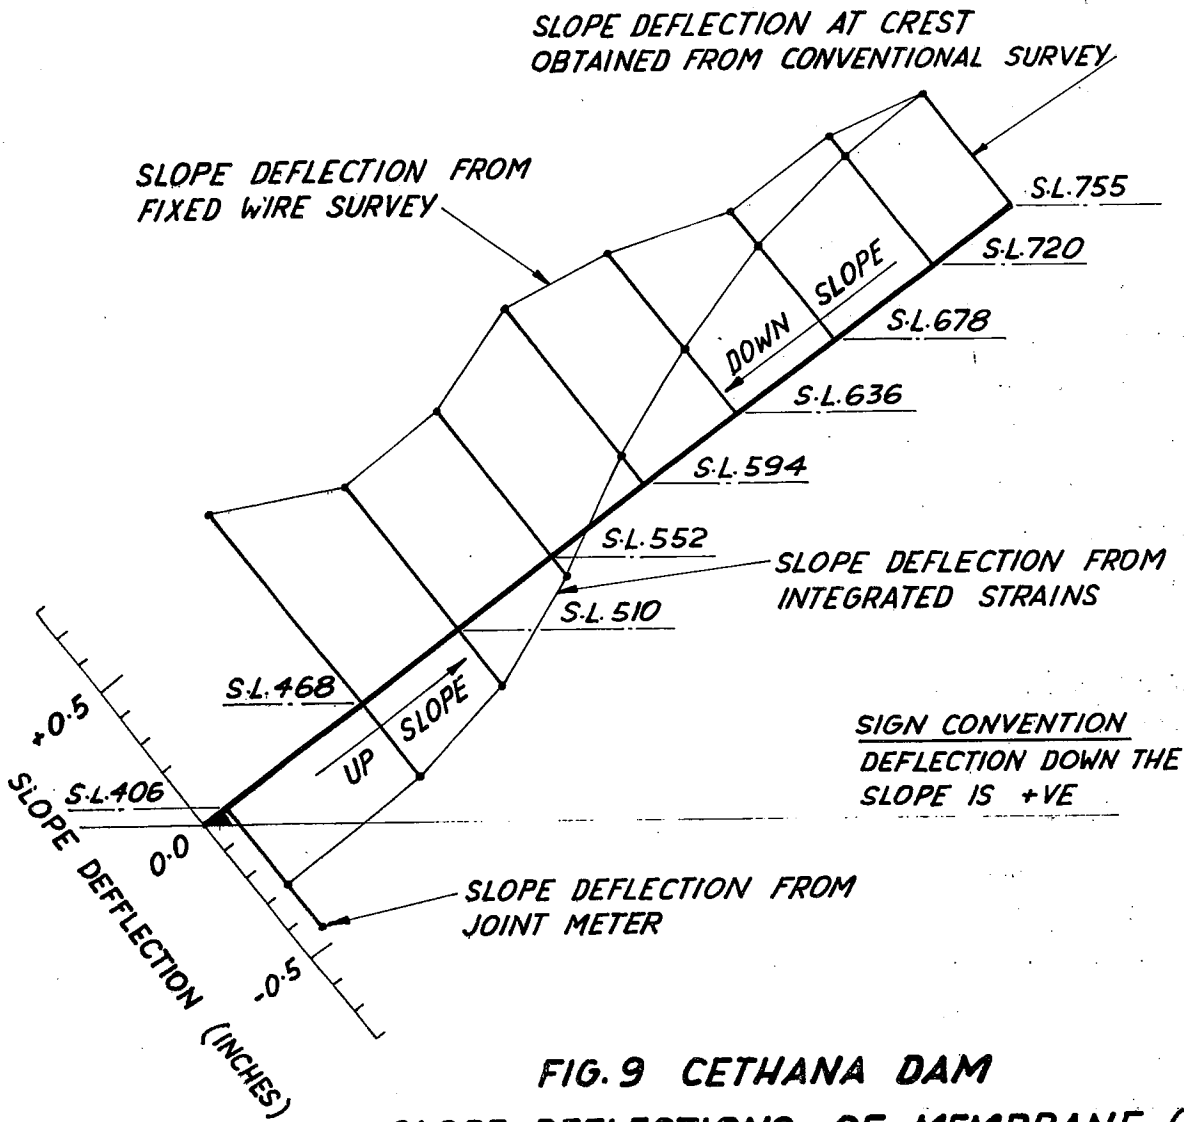
**FIG. 9 CETHANA DAM  
SLOPE DEFLECTIONS OF MEMBRANE (SLAB 9F)  
(8-12-71)**

The slope deflections at Cethana are measured by conventional survey at the crest, by fixed wire survey and integrated strains for points on the membrane and by joint meters at the toe. The results for 3 slabs are shown in fig 9 where it may be seen that the wire survey and integrated strain methods are not even in approximate agreement.

There is reasonable agreement, however, between the total shortening of the slab from strain integration and the total change in length as measured at the crest and toe of the slab. For this reason it is considered that the fixed wire survey is the more likely to be in error.

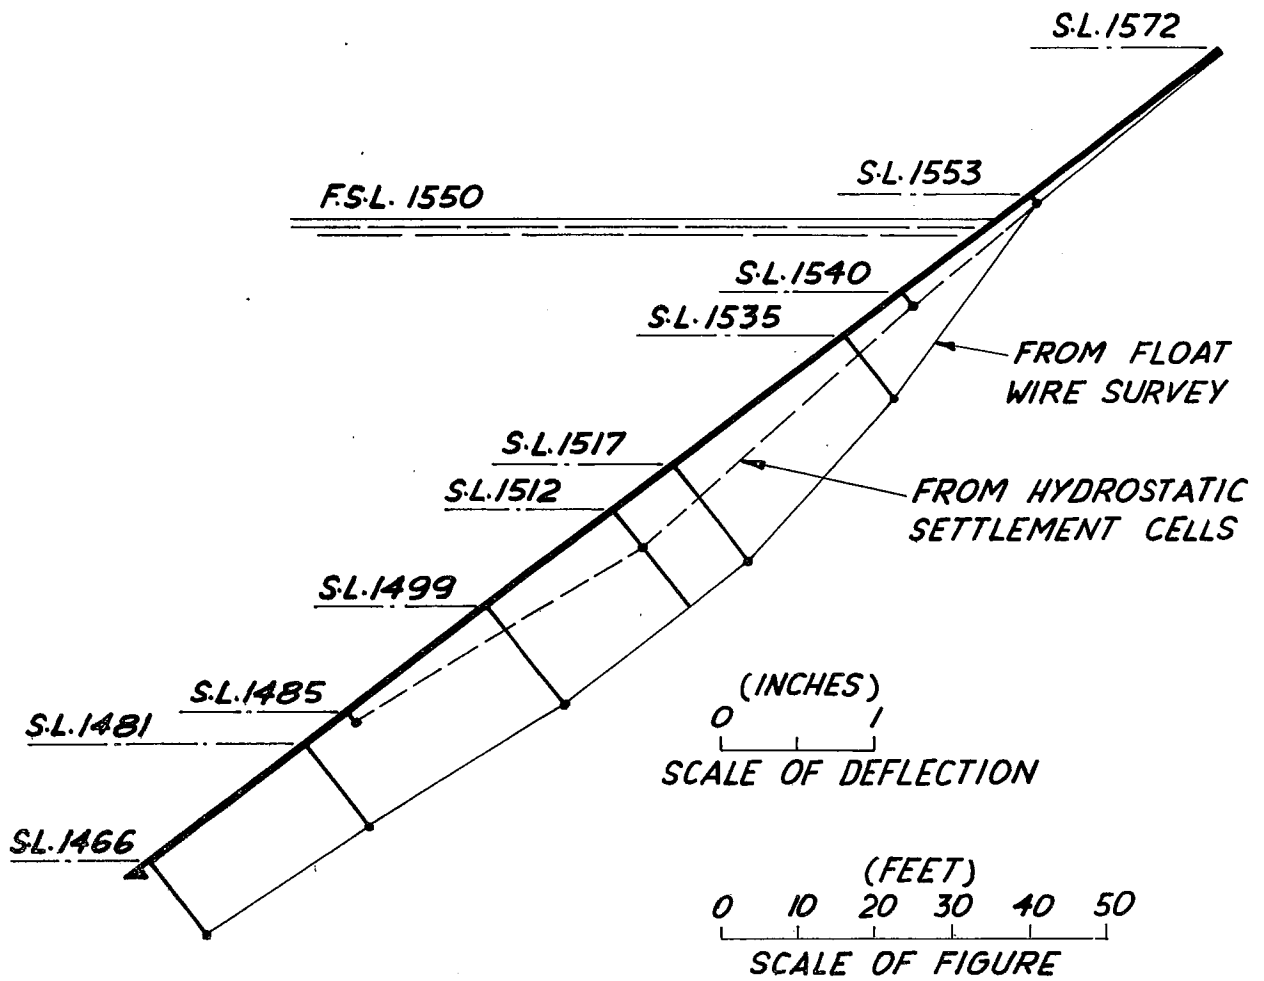
**FIG.II WILMOT DAM - NORMAL MEMBRANE DEFLECTION  
(24-4-70)**

Vertical deflections are measured by float wire survey and by hydrostatic settlement cells. The normal deflections calculated from the two sets of vertical deflection measurements are shown in fig 11.

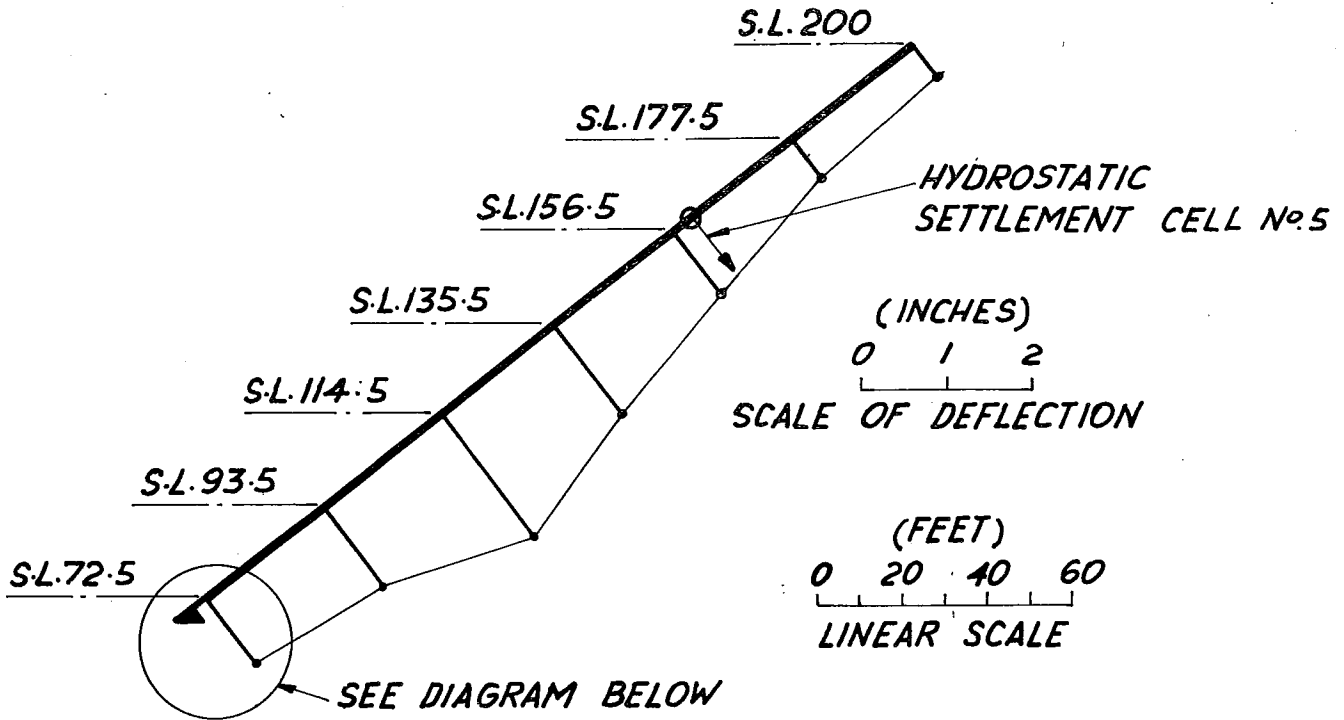
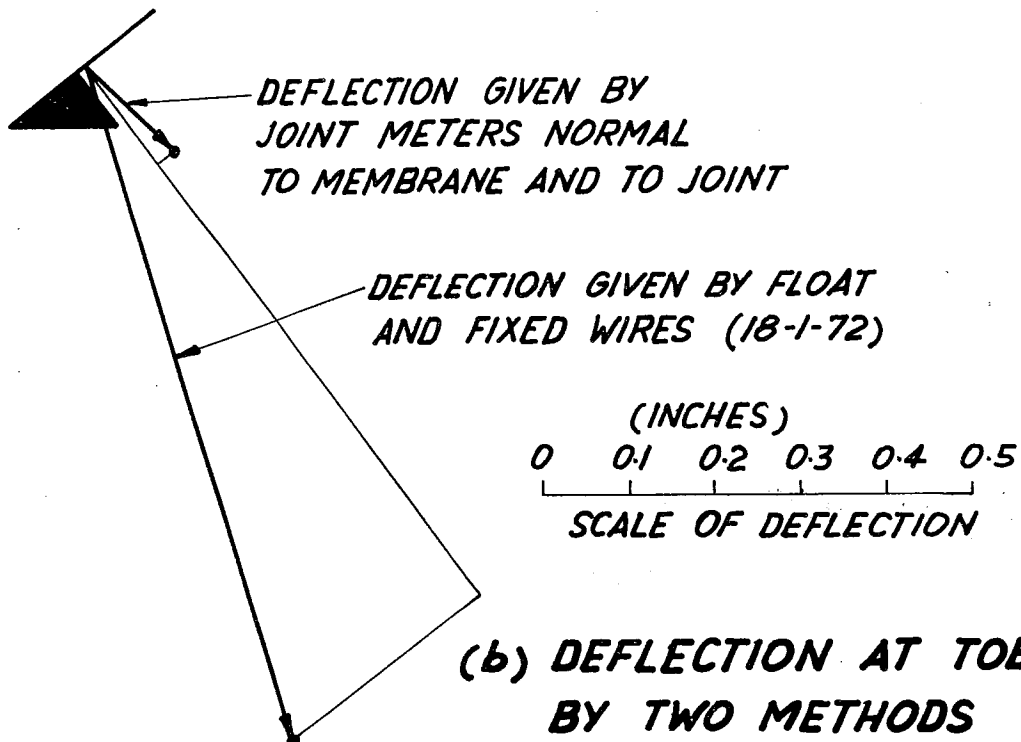
**(a) NORMAL DEFLECTION OF MEMBRANE FROM FLOAT WIRES (18-1-72)**

**(b) DEFLECTION AT TOE BY TWO METHODS**

**FIG.12 PALOONA DAM - MEMBRANE DEFLECTION (18-1-72)**

Fig 12a shows the normal deflections of the central section of the membrane as calculated from the float wire survey. The one hydrostatic cell very close to the underside of the membrane at SL 160 is in good agreement. However, at the toe the wire surveys give quite a different result from that measured by the joint meters - see fig 12b.

There is not a great deal of evidence on which to base a judgement but it is considered by the author that the wire measurements are likely to be the less reliable. This view is based mainly on the proven reliability, both in the laboratory and in the field, of hydrostatic settlement cells and electrical resistance joint meters.

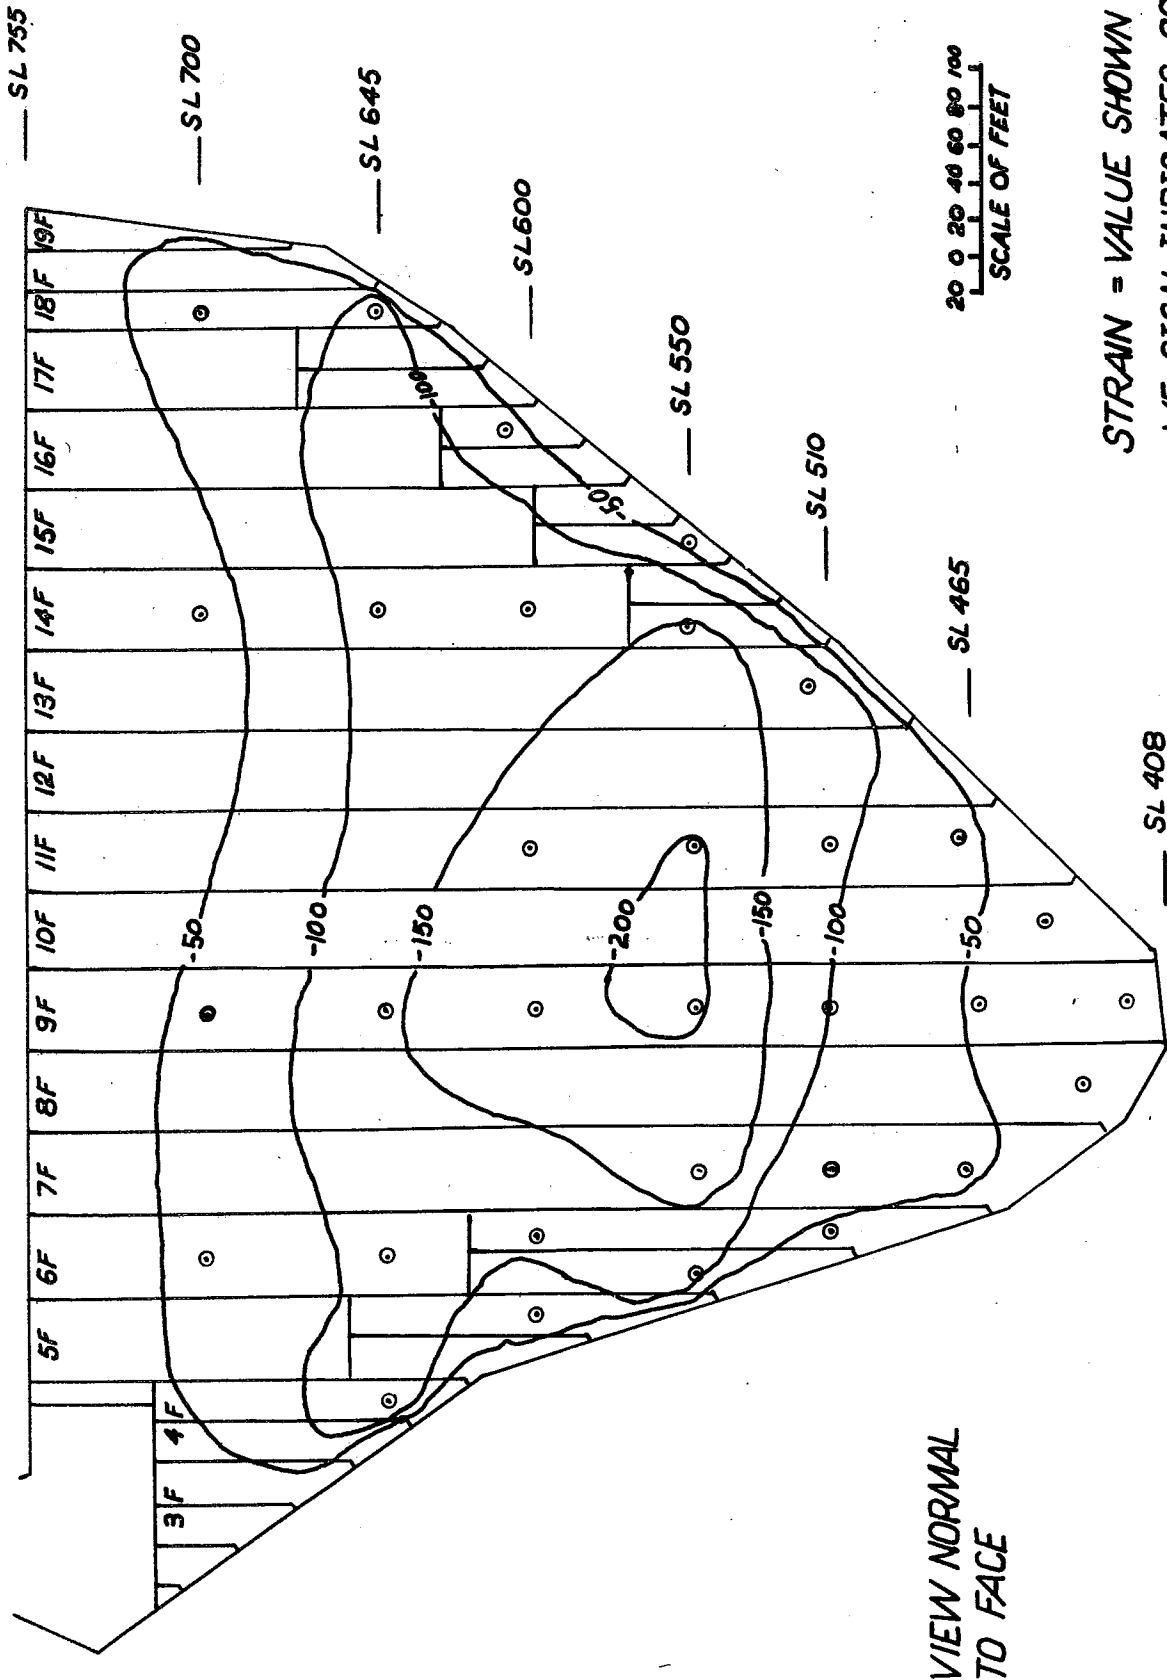
STRAIN = VALUE SHOWN  $\times 10^{-6}$

-VE SIGN INDICATES COMPRESSION

FIG 13. CETHANA DAM  
CONTOURS OF STRAIN IN MEMBRANE  
IN SLOPE DIRECTION. (4-2-71 to 8-12-71)

Cethana Dam is the only one in which membrane strains have been measured. The patterns of strain and stress developed in the membrane between the start of reservoir filling, 4th February 1971, and the 8th December 1971 are shown in figs 13, 14, 15 and 16.

The pattern of strain in the slope direction, fig 13, is reasonably symmetrical about slabs 9F and 10F in the centre of the membrane. Over a fairly large area the strain is greater than  $150 \times 10^{-6}$  units and in a much smaller region within this central area it is a little greater than  $200 \times 10^{-6}$  units.

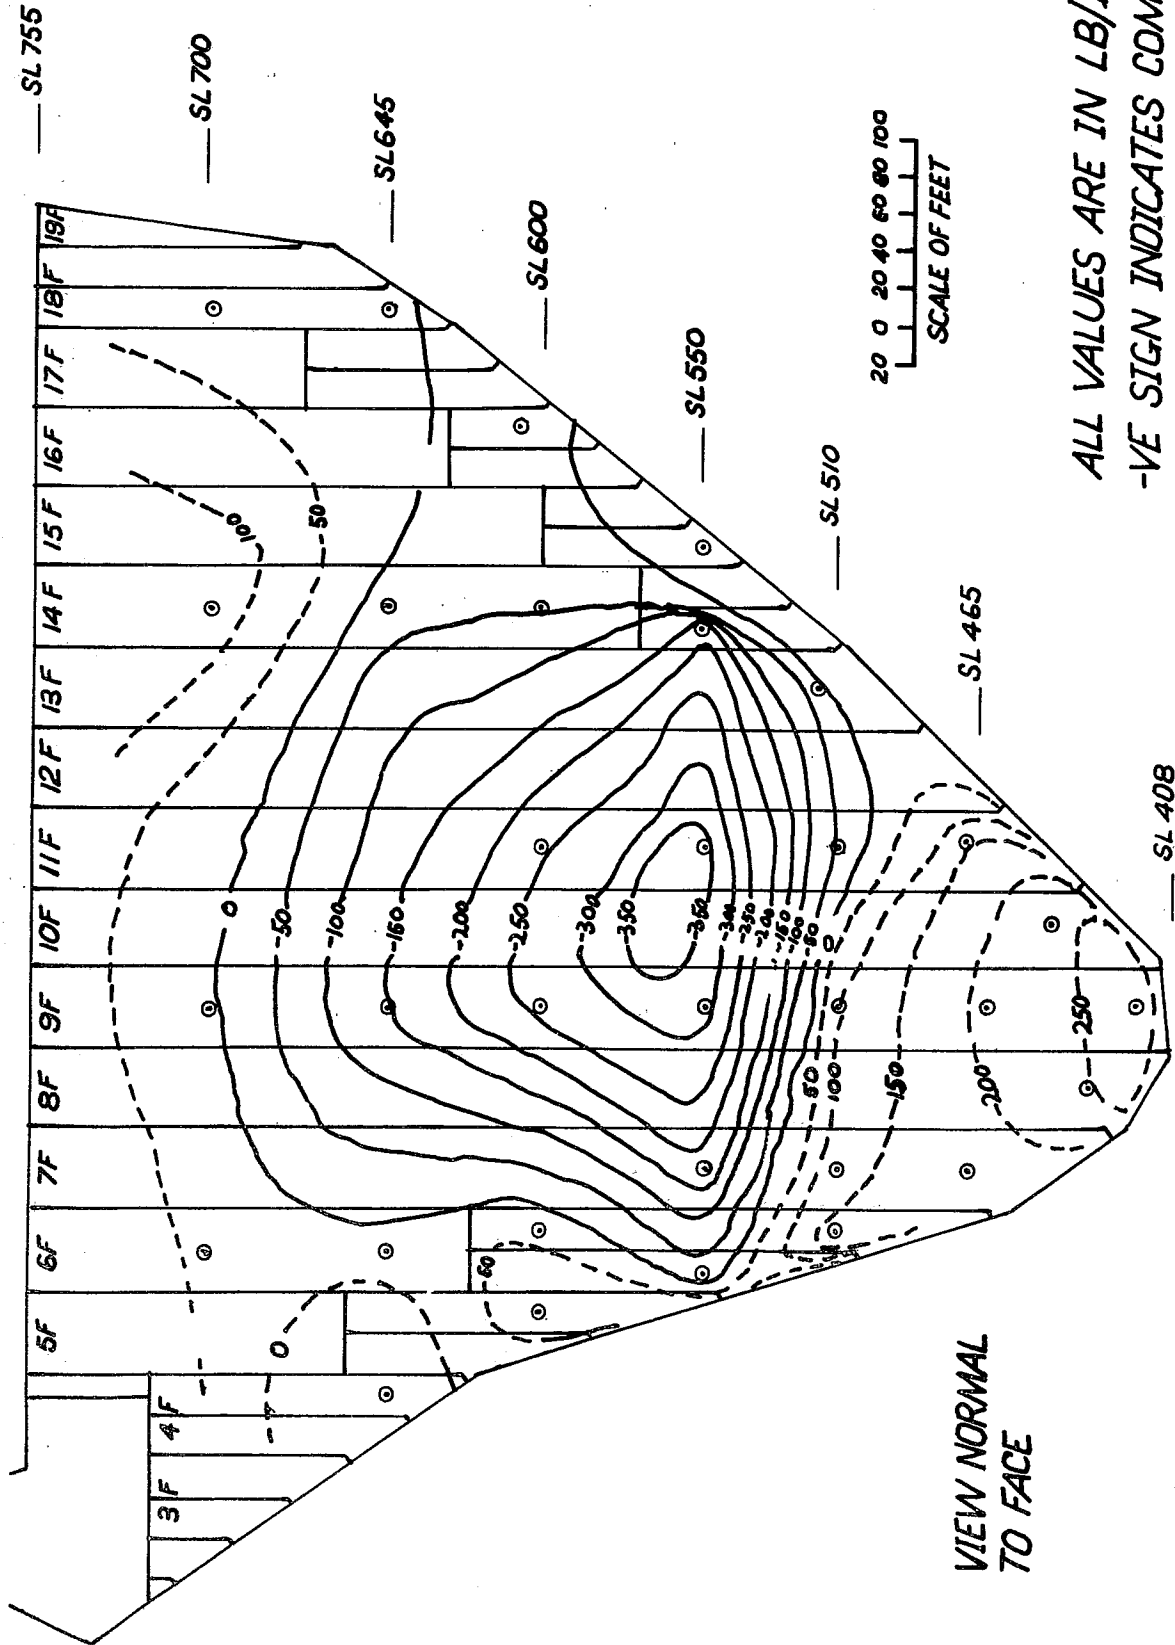
ALL VALUES ARE IN LB/IN<sup>2</sup>  
-VE SIGN INDICATES COMPRESSION

FIG 14. CETHANA DAM  
CONTOURS OF STRESS IN MEMBRANE  
IN SLOPE DIRECTION. (4-2-71 to 8-12-71)

Stress in the slope direction, fig 14, reflects the strain pattern with maximum stress in the central region being about  $350 \text{ lb/in}^2$ . Tensile stresses exist in the lower one third of the membrane, in a narrow region up each abutment and across the top portion of the membrane. The maximum tension is  $250 \text{ lb/in}^2$  near the toe in slab 9F.

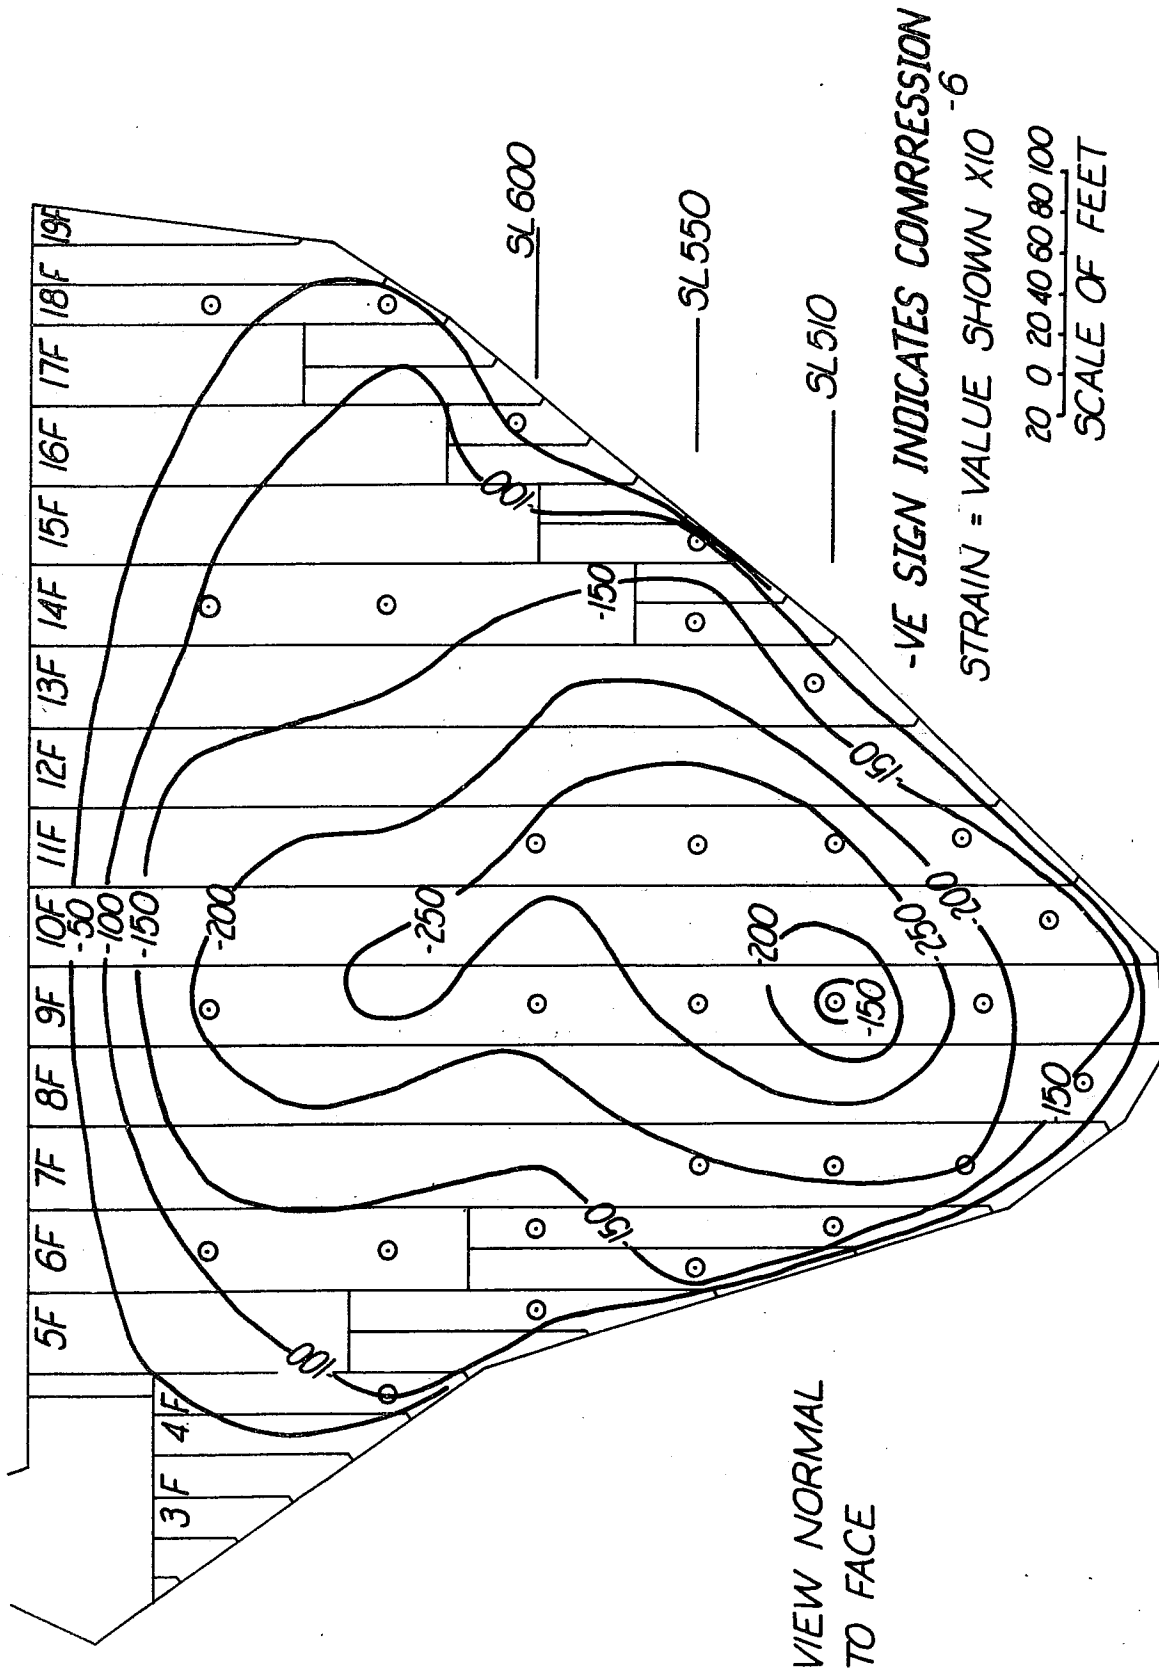
FIG.15 CETHANA DAM - CONTOURS OF STRAIN IN MEMBRANE IN HORIZONTAL DIRECTION

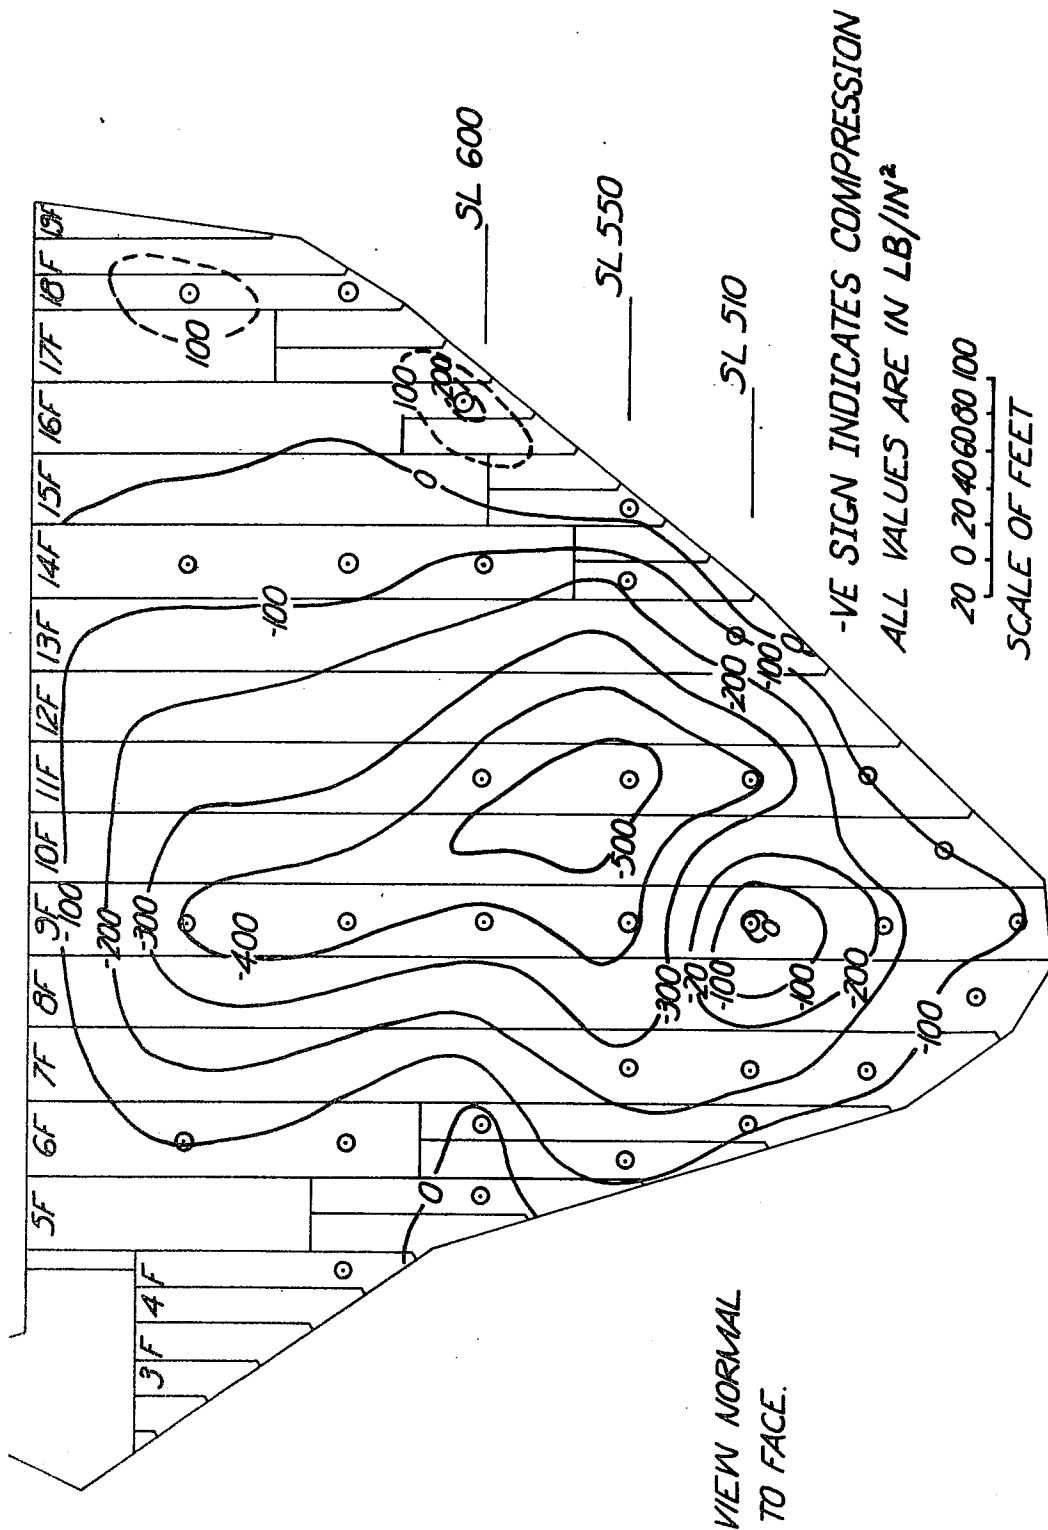
FIG 16. CETHANA DAM - CONTOURS OF STRESS IN MEMBRANE  
IN HORIZONTAL DIRECTION  
(4.2.71-8.12.71)

Stresses were calculated using values of the elastic constants of  $3 \times 10^6$  lb/in<sup>2</sup> for Young's Modulus and 0.2 for Poisson Ratio.
