DESIGN OF A LANDSLIDE REMEDIATION SCHEME FOR A 42 LOT SUBDIVISION AT WINSTON HILLS, SYDNEY

ABSTRACT

A 42 lot subdivision proposed for a known landslip area at Buckleys Road Winston Hills required the geotechnical design of earthworks to remediate the site. An initial remediation proposal using an anchored retaining wall was abandoned in favour of an earthworks solution involving the removal of the failed material, installation of a drainage blanket and replacement of engineered fill. In order to reduce earthworks costs a alternative earthworks solution was also developed where only the sloping portions of the site were treated and the flatter central area was untreated. Detailed earthworks design included treatments at the site boundary where the landslip extends outside the site boundary, a foundation inspection and testing regime and earth bunds to deflect potential future failures from the neighbouring property.

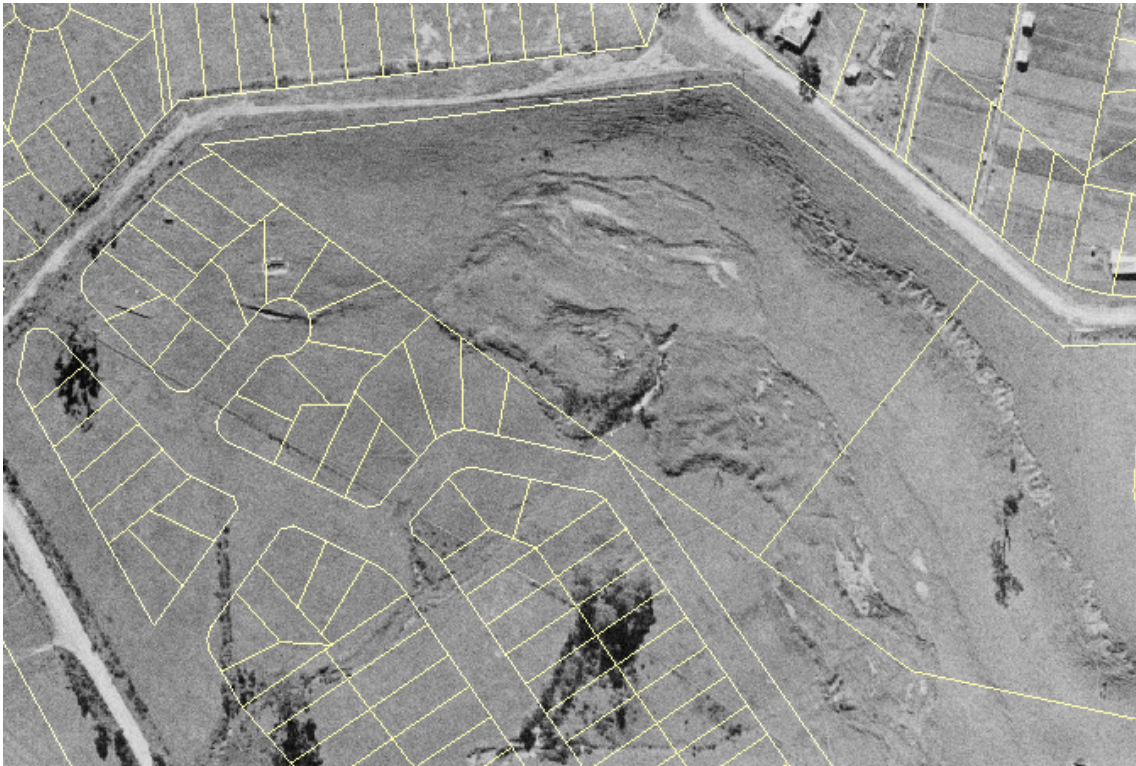
Figure 1: Air Photo dated 1943 with Cadastre (NSW Department of Lands).

The proposed subdivision incorporates 42 residential lots with access provided by a subdivision road from Buckleys Road (Figure 1). Site stormwater and sewerage are directed via an easement through a public reserve to the existing services in Rebecca Place.
