ISSUES WITH GEOTECHNICAL INVESTIGATIONS, DESIGN AND CONSTRUCTION IN REMOTE LOCATIONS

This paper discusses the complexities of providing geotechnical design parameters for rock anchors and shallow foundations for an access stairwell at the 20 m high, vertical walled, To Sua Ocean Trench in Samoa.

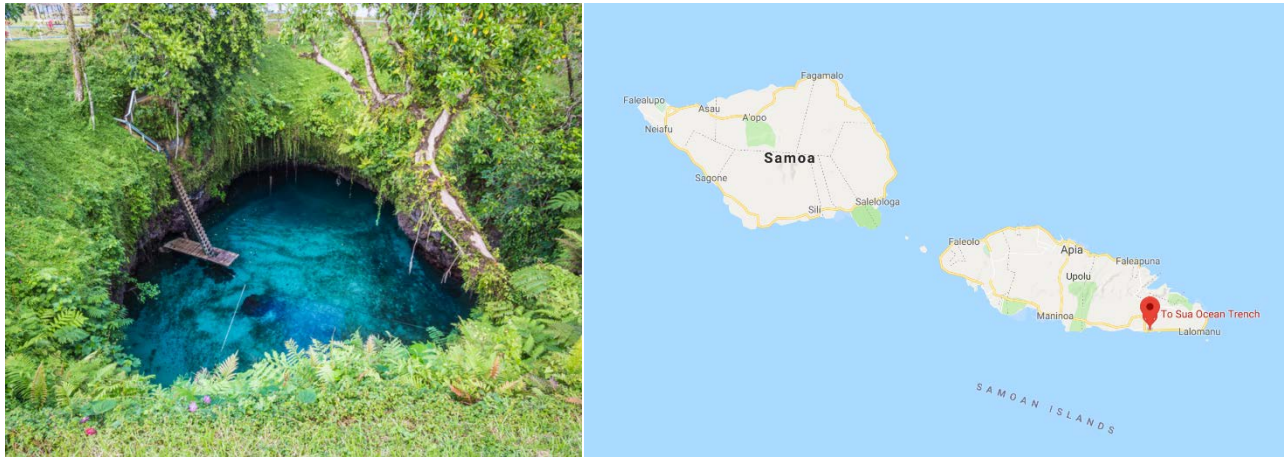
Figure 1: Aerial view and location of the To Sua Trench. Image (left) sourced from www.samoa-travel/ and map (right) sourced from Google Maps.

The To Sua trench is a popular tourist attraction located adjacent to the south-eastern coast of the island of Upolu in Samoa. The trench is up to 30 m wide, and approximately 20 m in height (from ground level at the top to water level at the base). Current access to the base of the trench is via an 18 m high, narrow timber ladder, fixed precariously to the top and bottom of the trench, and standing at approximately 70° (shown in Figure 1). The site is just over an hours' drive from Apia, where the majority of the country's major development projects exist. Aside from it being an international location, the site is also considered to be in a remote area within Samoa as the surrounding area is largely undeveloped and densely vegetated.

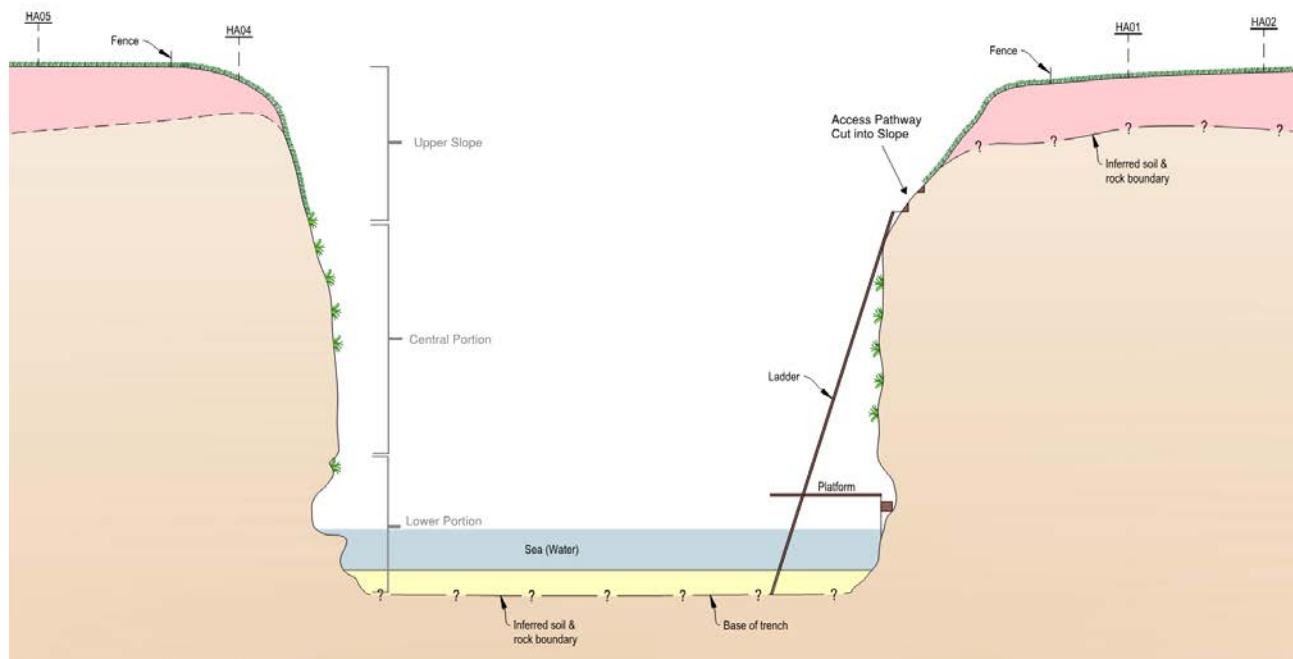
Figure 2: Cross-Section through the To Sua Trench

Based on our review of the Google Images, combined with our subsequent site observations, the structure of the trench can be described as having three geotechnically distinct layers. These have been defined as the lower portion, central portion, and upper slope. This is further illustrated in Figure 2 below.

The upper portion of the slope reclines between 30° and 70° and is densely vegetated with mature trees and shrubs. With the exception of the access path cut into the slope, this slope does not appear to have been modified.

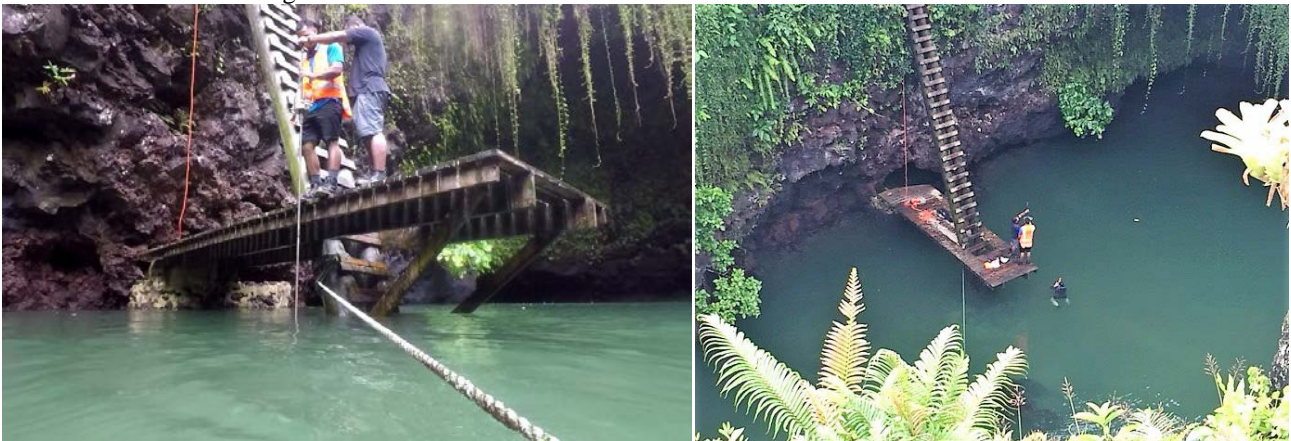
Figure 3: Undertaking Scala penetrometer testing from the platform at the base of the ladder and evaluating the base of the trench through swimming.

- Evaluation of the base of the trench through swimming / diving, and Scala penetrometers (undertaken from the ladder platform) to understand the material at the base of the trench and assess the depth to competent rock for foundation support.
