The Albany Regional Centre Development

A J Linton

Foundation Engineering Limited, Auckland, New Zealand

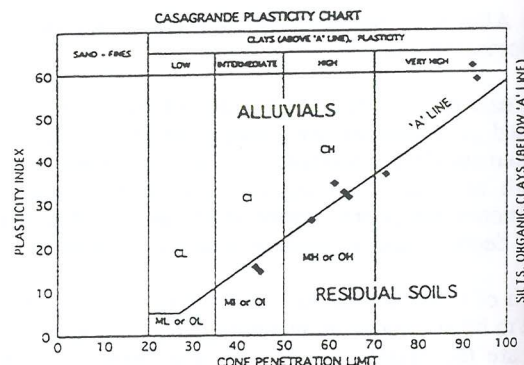
Figure 2. Casagrande Classification Results

On this site, within the weathered Waitemata Group, testing showed the material to be generally an inorganic silt, within the Pleistocene alluvium, testing showed this material to be generally an inorganic clay. Figure 2 shows Casagrande Classifications for samples taken from different geological terrain present on the Albany Region site.
