# The Construction of a Zoned Embankment Dam in Indonesia

**Summary** This paper documents the construction of a 30m high water storage dam at the Bukit Sentul Project in West Java, Indonesia. The author was extensively involved in the design phase of Dam L2 and spent a subsequent six month period in Indonesia for the construction of the embankment. This paper discusses the major technical and engineering issues which arose, as well as focusing on the more practical aspects of living, working and managing a project in a foreign country.

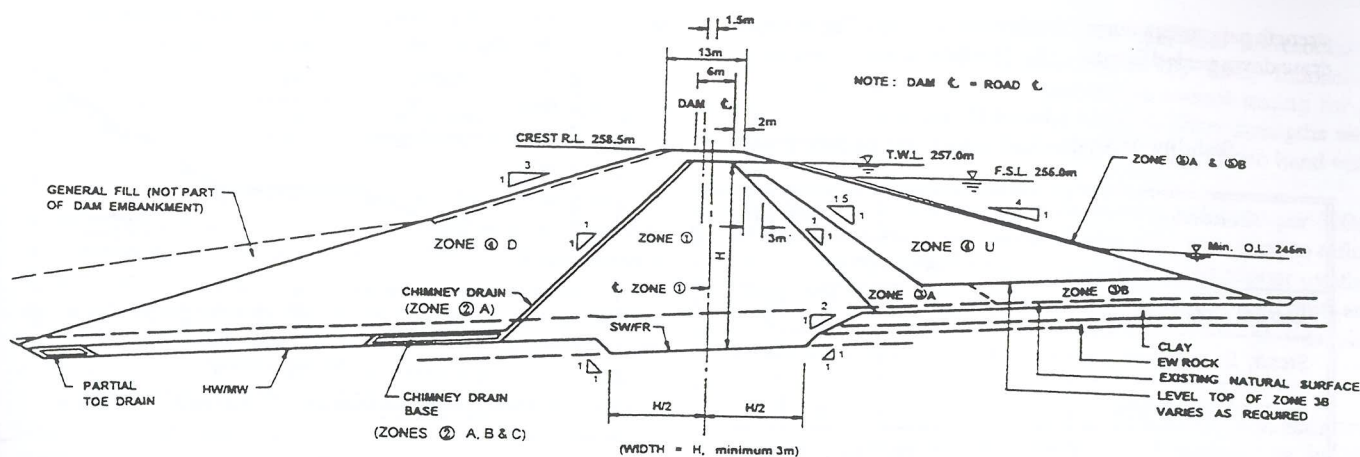
Figure 2 Dam L2 - Typical Cross Section

As with most embankments, the profile adopted for Dam L2 was governed by material availability. The client had planned to construct the dam coincident with major subdivisional works on the plateaus immediately north and east of the site, and these locations were set aside as embankment material borrow sources. Following investigation and testing of material properties, it was deemed that the clays and underlying claystone from these excavations would be suited to a zoned earth/soft rockfill embankment profile, and the typical section shown in Figure 2 was adopted.

Zone 2 materials form the downstream filter and drainage system. **Zone 2A** is clean, durable filter sand, and with an outer layer of geotextile forms the Chimney Drain. **Zone 2B** (nominal size 10mm) and **Zone 2C** (nominal size 20mm) are drainage materials consisting of screened gravels. These three materials together with geotextiles are incorporated in various "sandwich" arrangements to form the Chimney Drain Base, the Drainage Blanket and the Toe Drain.

A Seepage Collection System comprising perforated collection pipes, concrete collection chamber and outfall pipe are located in the Blanket Drain at the downstream toe. This arrangement was necessary as the deep subdivisional fill over the downstream toe eliminated the option of conventional toe drains.

The central **Zone 1** Core consists of compacted medium to high

**Zone 3A** formed the upstream shoulder transition, and is made up of extremely to moderately weathered claystone compacted to a Dry Density Ratio of 95% (Standard) with moisture contents in the range 2% dry to 4% wet of optimum. **Zone 3B** consisted of similar material, and was incorporated into the floor of the upstream shoulder.

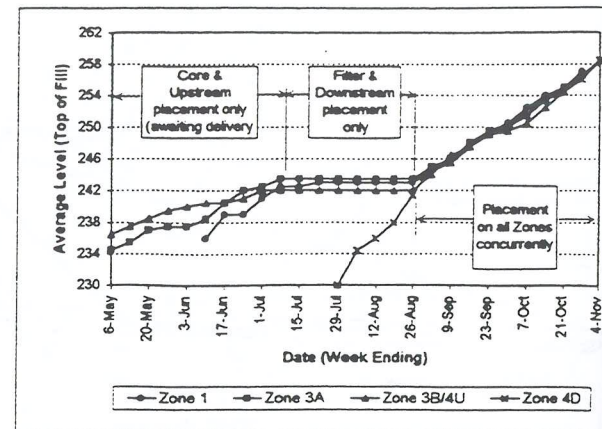
**Figure 3** Dam L2 - Progress of Raising

The construction process is presented graphically in Figure 3. The construction time was of longer duration than originally forecast, and this can be attributed to three main factors:

- *Filter Material* - delays in provision of Zones 2B and 2C filter materials were a great concern during the first few months of construction, as evident in Figure 3. Random quality of materials, poor roads, long haulage distances and small, inappropriate trucks resulted in extremely slow delivery rates and the eventual postponement of all earthworks on the core and upstream shoulder for four weeks.

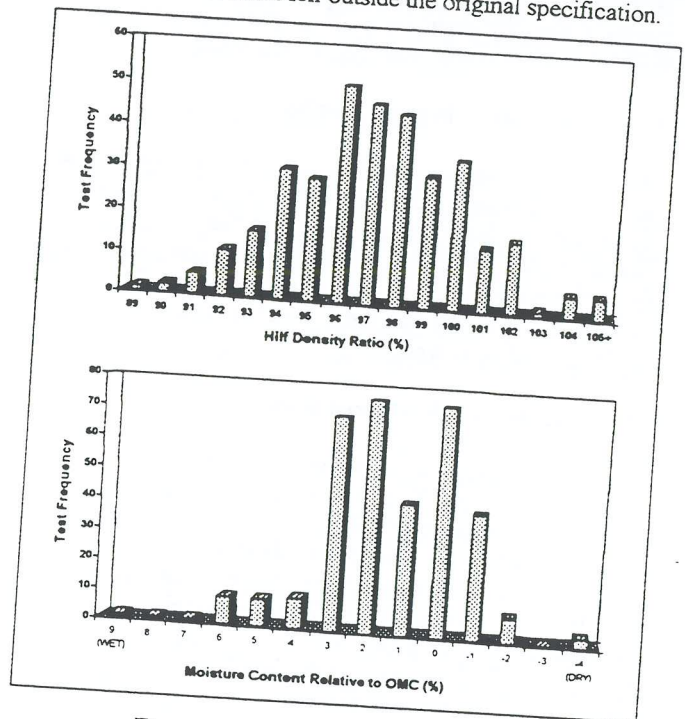
Figure 4 Zone 1 Compaction Control

The distribution of Zone 1 compaction control testing is presented in Figure 4. The density ratio histogram indicates that, of the 348 tests conducted, only 19 results fell below 92%, hence requiring recompaction and retesting. The variable field moisture contents are demonstrated in the second histogram. It can, however, be seen that only 12% of results fell outside the original specification.

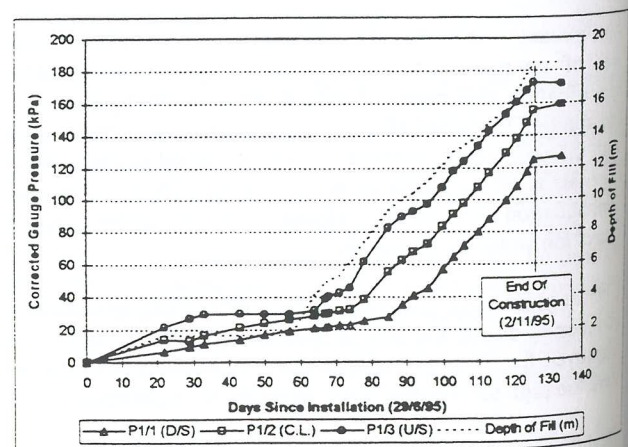
Figure 5 Zone 1 Piezometer Readings During Construction

The build-up of pore pressures within the embankment were monitored by reading each piezometer and recording its associated depth of fill twice a week. The piezometers in Zone 4U showed little fluctuation due to the depth of rockfill above them; instead their fluctuations reflected rainfall patterns. Zone 1, and to a lesser extent Zone 3A showed a steady, almost linear increase in pore pressure with depth of fill, which was not unexpected, given the wet placement conditions. This increase can be seen for the Zone 1 piezometers in Figure 5. These results indicate the pore pressure parameter,  $r_u > 0.5$ , which retrospectively justifies the design based on undrained strength. Note also how pressures began to level out upon completion of fill placement.
